Re: BOL # 1191150002 — Madison County
Roxana/Equilon Enterprises LLC dba Shell Oil Products US
Compliance File

RCRA Inspection Report

BOL ID	1191150002	Evaluation Date	6/21/2023
USEPA Id	ILD080012305	Region	Collinsville
Site Name	Equilon Enterprises LLC dba Shell Oil Products US	County	Madison
Address	900 S. Central Ave.	Phone	484-632-7955
City/State/Zip	Roxana, IL 62084	EJ Status	Low Income
Limited English	<input type="checkbox"/>	Primary Language	English

RCRA Program - Compliance Evaluation Inspection

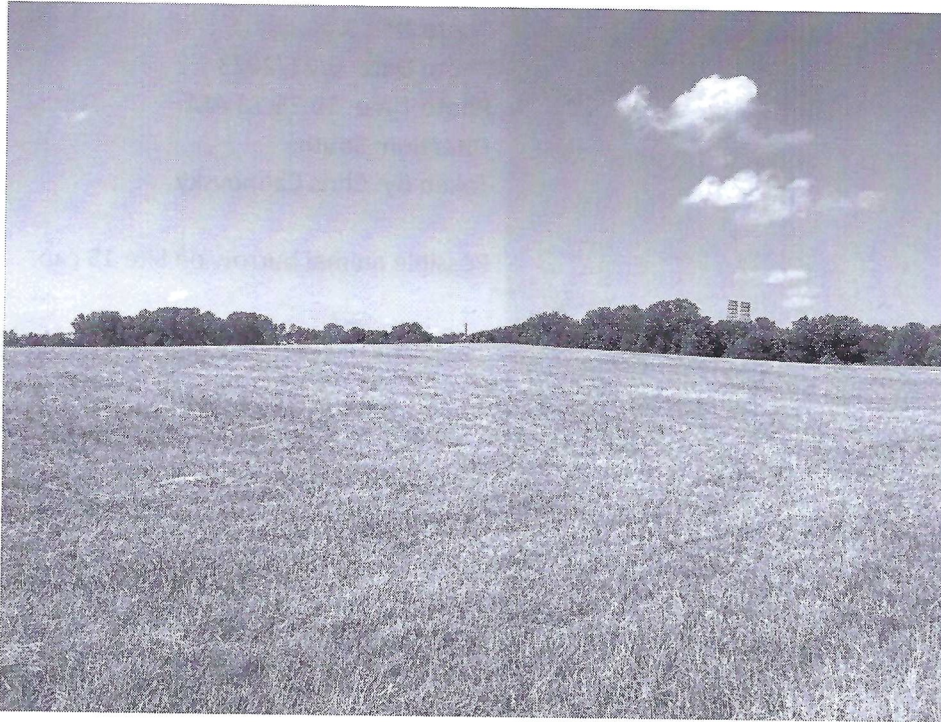
Bureau Id: 1191150002
Photo No.: 1
Photo Date: 6/21/2023
Photo Time: 10:19:33 AM
Direction: South
Taken By: Chris Cahnovsky

Vegetative cap on Site 15

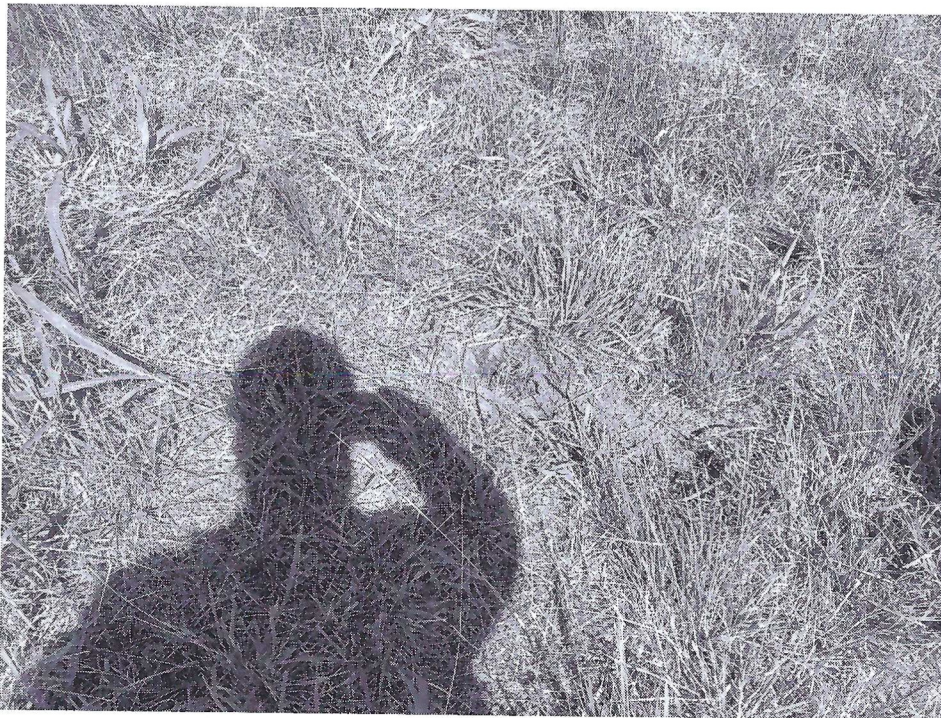
Bureau Id: 1191150002
Photo No.: 2
Photo Date: 6/21/2023
Photo Time: 10:24:19 AM
Direction: Northwest
Taken By: Chris Cahnovsky

Illinois EPA personnel walked the cap of Site 15. The cover vegetation appeared to be in good condition. No erosion or leachate seeps were observed. I observed what appeared to be animal burrows in the cap. None of the burrows that I observed appeared to extend beyond six inches in depth. The required signs were posted at the entrances to Site 15. Quarterly inspections and descriptions of corrective actions taken to repair the landfill cap are being documented by AECOM on the Post-Closure Inspection Checklist.

Possible animal burrow on Site 15 cap.

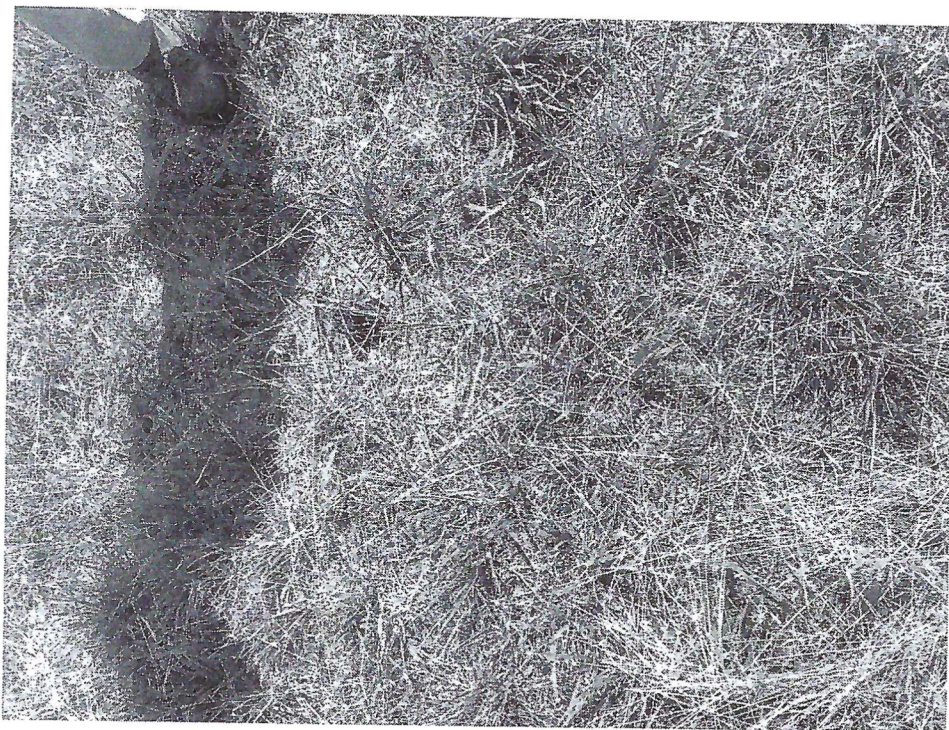
Bureau Id: 1191150002
Photo No.: 3
Photo Date: 6/21/2023
Photo Time: 10:25:13 AM
Direction: South
Taken By: Chris Cahnovsky

Possible animal burrow on Site 15 cap.

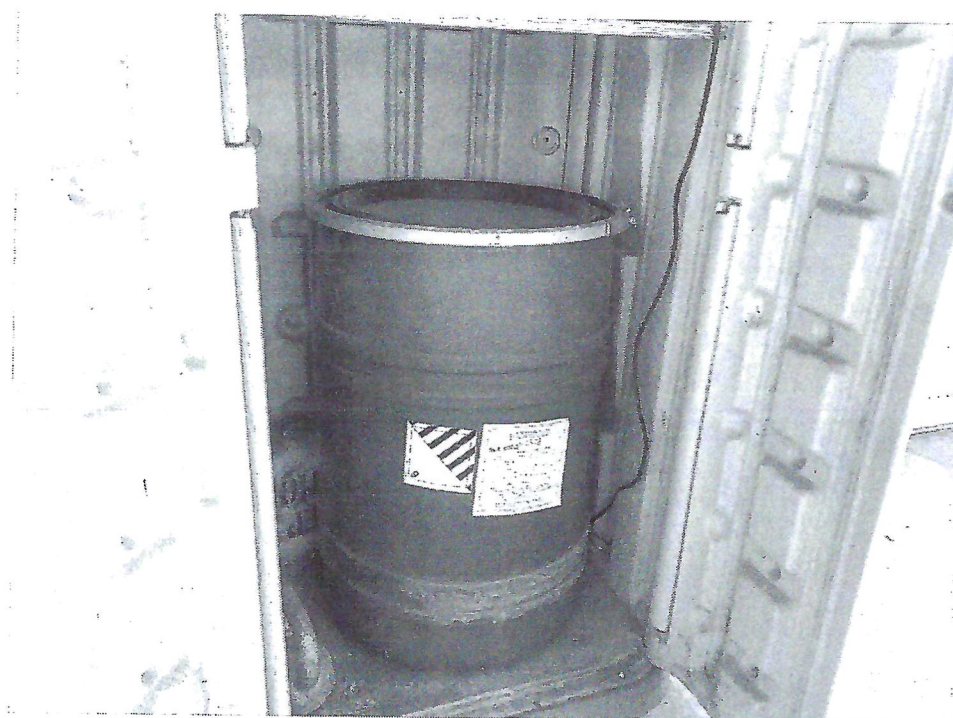
Bureau Id: 1191150002
Photo No.: 4
Photo Date: 6/21/2023
Photo Time: 10:56:25 AM
Direction: Southeast
Taken By: Chris Cahnovsky

The VLS units are located inside the east conex. Sediment entrained in the vapor flow accumulate inside each VLS unit and is periodically removed. The hazardous waste sediment is removed from the VLS units and containerized in a 30-gallon plastic container staged at the satellite accumulation area located outside on the west side of the east conex. This satellite accumulation drum of benzene contaminated hazardous waste sediment (U019) was properly closed and labeled. I observed the required emergency equipment also staged outside of the east conex.

Satellite accumulation drum for waste
from soil vapor extraction system.

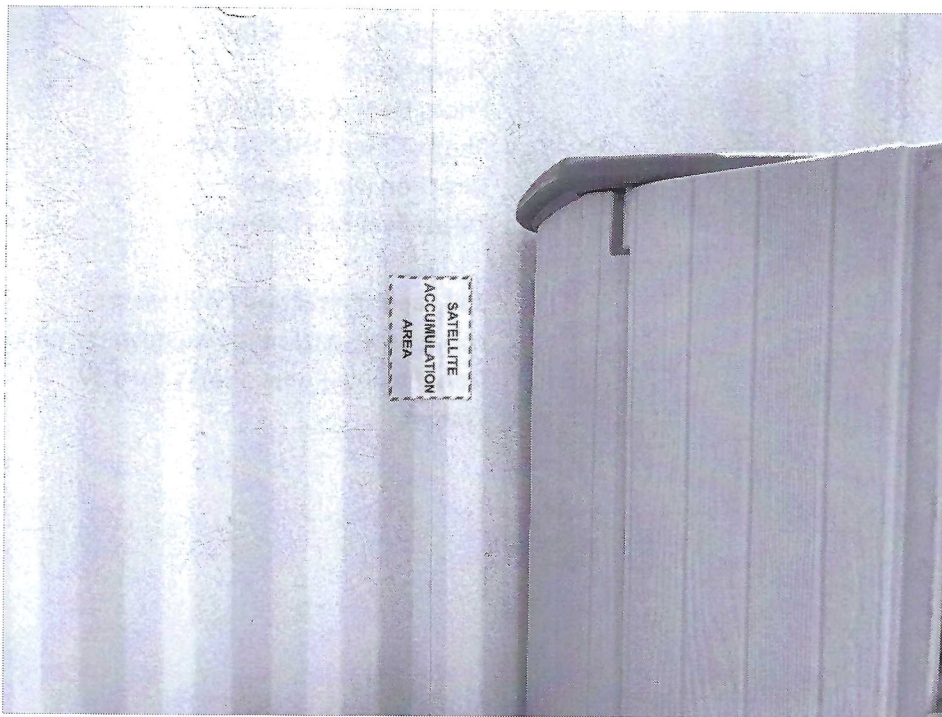
Bureau Id: 1191150002
Photo No.: 5
Photo Date: 6/21/2023
Photo Time: 10:56:31 AM
Direction: East
Taken By: Chris Cahnovsky

Satellite Accumulation Area.

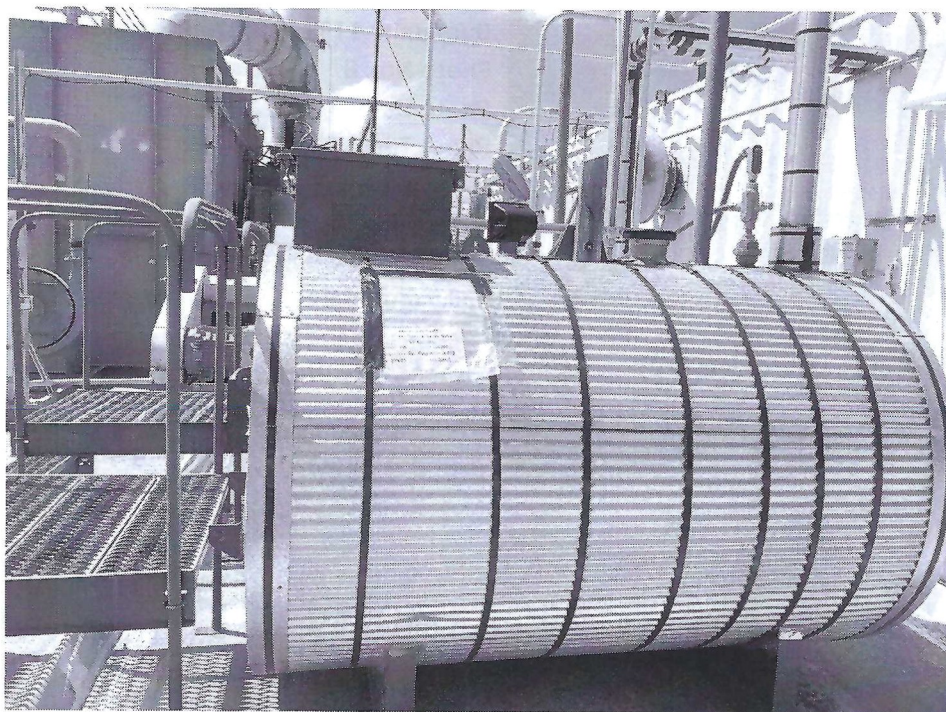
Bureau Id: 1191150002
Photo No.: 6
Photo Date: 6/21/2023
Photo Time: 11:01:35 AM
Direction: South
Taken By: Chris Cahnovsky

Condensate which drops out the vapor stream and into the VLS units is pumped to two 625-gallon, double-walled, above ground storage tanks (ASTs) located outdoors on the east side of the east conex. Tank #2 or WF AST is used for the storage of condensate from the West Fenceline portion of the system. The condensate from this tank is discharged through WRR's National Pollutant Discharge Elimination System (NPDES) permitted wastewater treatment plant (WWTP). The condensate water is transported by vacuum truck to Site 9 inside the WRR facility.

Soil vapor extraction (SVE) system
condensate water tank from refinery
SVE system.

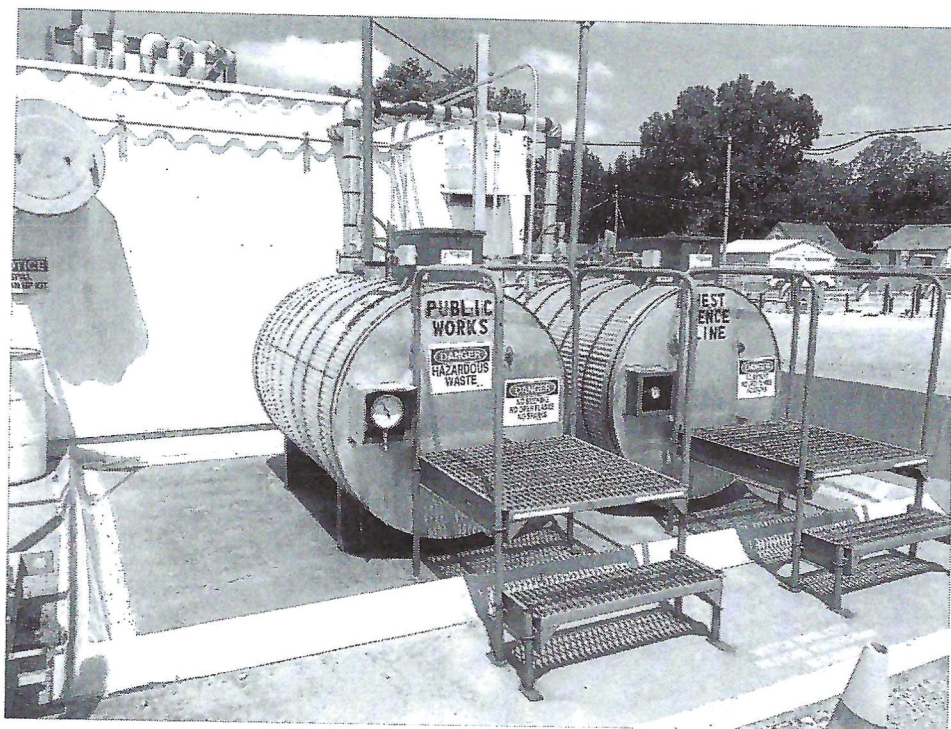
Bureau Id: 1191150002
 Photo No.: 7
 Photo Date: 6/21/2023
 Photo Time: 11:02:56 AM
 Direction: Northwest
 Taken By: Chris Cahnovsky

The second tank, Tank #1 or PW AST, is used as a less than 90-day hazardous waste accumulation tank of condensate generated from SVE activities on PW property located at 143 East 8th Street in Roxana.. This condensate is managed as a listed hazardous waste for benzene carrying a U019 waste code. The condensate from the PW property is not managed in the WRR's WWTP because it is generated from the portion of the SVE that is not located on WRR property. The waste condensate is either shipped off-site in bulk or pumped into 55-gallon drums.

The secondary containment for the PW AST is provided via a double-walled tank. The tank is monitored daily to ensure that a vacuum is maintained within the space between the tank walls. This tank was empty at the time of this inspection. During cold weather months the tank is emptied about every two weeks. The tank was labeled with the words "Hazardous Waste." A tank assessment per 35 Ill Adm. Code 725.292 was conducted by URS on March 29, 2013. This tank and associated equipment are not subject to RCRA Subparts BB and CC for organic air emissions.

Soil vapor extraction (SVE) system
 condensate hazardous wastewater tank
 from Roxana Public Works Yard SVE
 system.

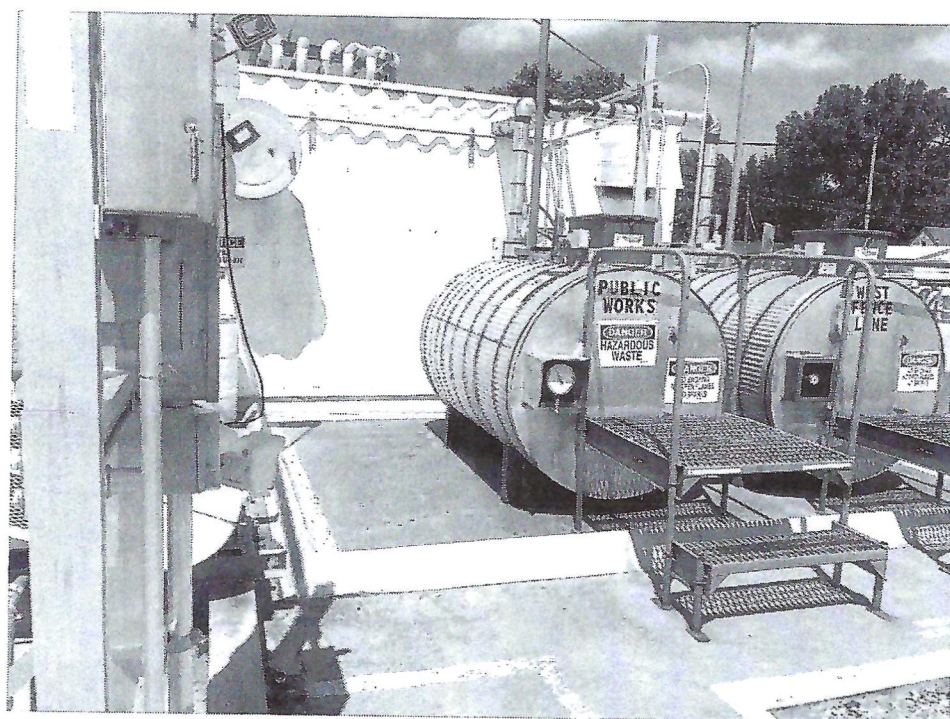
Bureau Id: 1191150002
 Photo No.: 8
 Photo Date: 6/21/2023
 Photo Time: 11:08:42 AM
 Direction: Northwest
 Taken By: Chris Cahnovsky

Soil vapor extraction (SVE) system
 condensate hazardous wastewater tank
 from Roxana Public Works Yard SVE
 system.

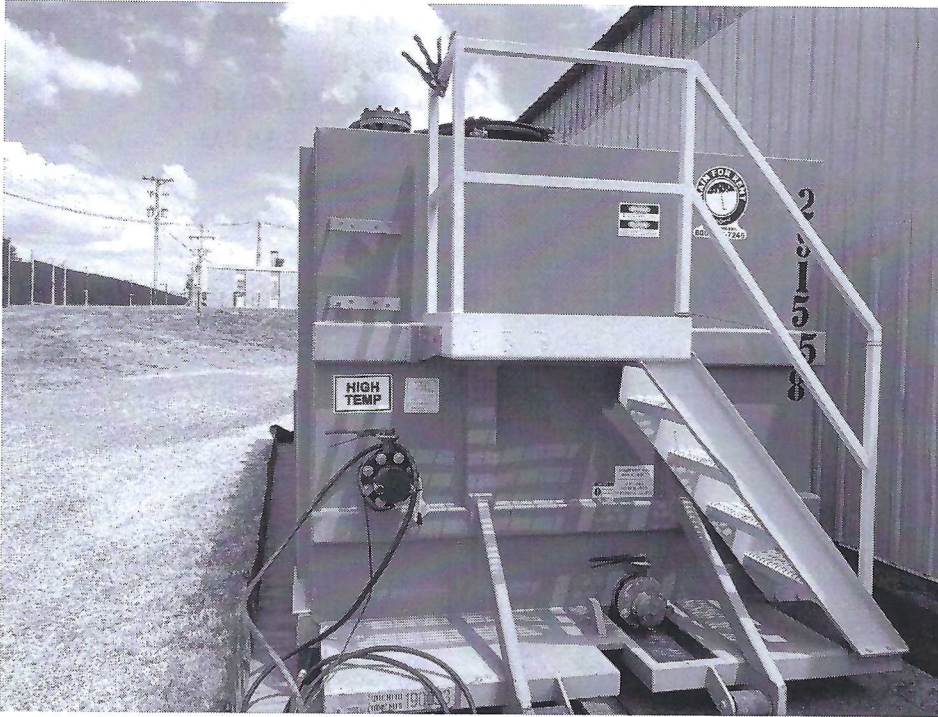
Bureau Id: 1191150002
Photo No.: 9
Photo Date: 6/21/2023
Photo Time: 2:18:44 PM
Direction: East
Taken By: Chris Cahnovsky

Hazardous waste purge water from
Roxana Public Work Yard. No indication
of hazard label.

AECOM, on behalf of SOPUS, is constructing and will be operating and maintaining a Steam Enhanced Extraction (SEE) system located on the Former Public Works Yard (FPWY) property in Roxana. Waste generated during the construction of the SEE are soil cuttings, debris (tubing, personal protective equipment), groundwater/purge water, and drilling soils. The groundwater/purge water will be managed as a hazardous waste for benzene (U019). At the FPWY, I observed a 9,000-gallon frac tank containing about 100 gallons of groundwater/purge water and a 15-yard roll-off box of soil cuttings. Both containers were labeled with the words "Hazardous Waste." The frac tank and roll-off box had accumulation start dates of June 20, 2023 and April 24, 2023, respectively. Both containers were not labeled with indications of the hazards of the contents as required by 35 Ill. Adm. Code 722.117(a)(5)(A)(ii). However, Mr. Fisher labeled the two containers with Department of Transportation Class 9 labels during the inspection.

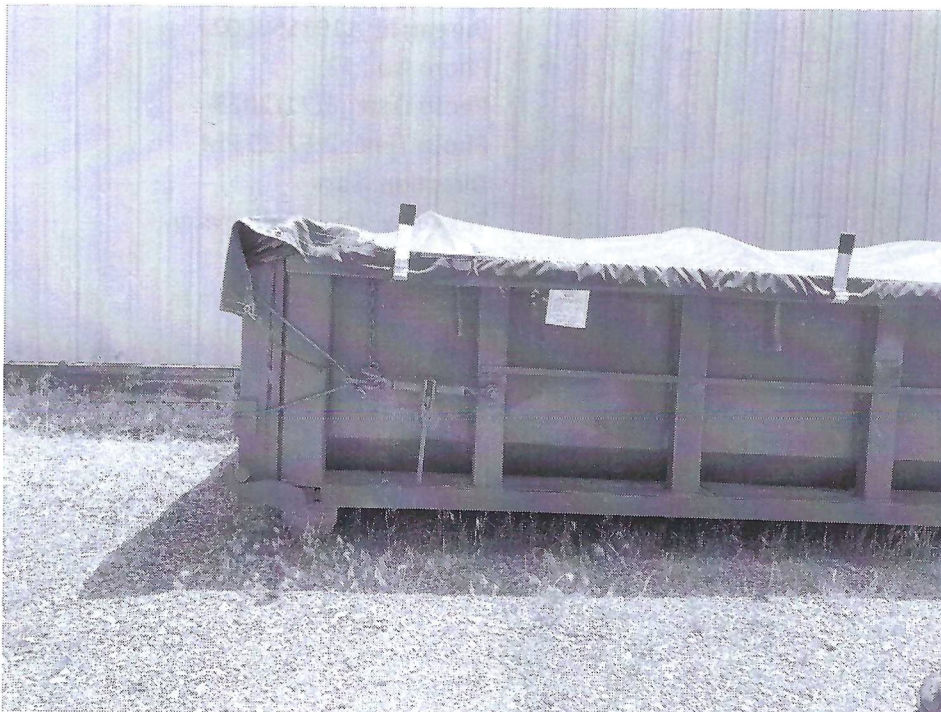
Bureau Id: 1191150002
Photo No.: 10
Photo Date: 6/21/2023
Photo Time: 2:19:01 PM
Direction: South
Taken By: Chris Cahnovsky

Hazardous waste soil from Roxana Public
Works Yard. No indication of hazard
label.

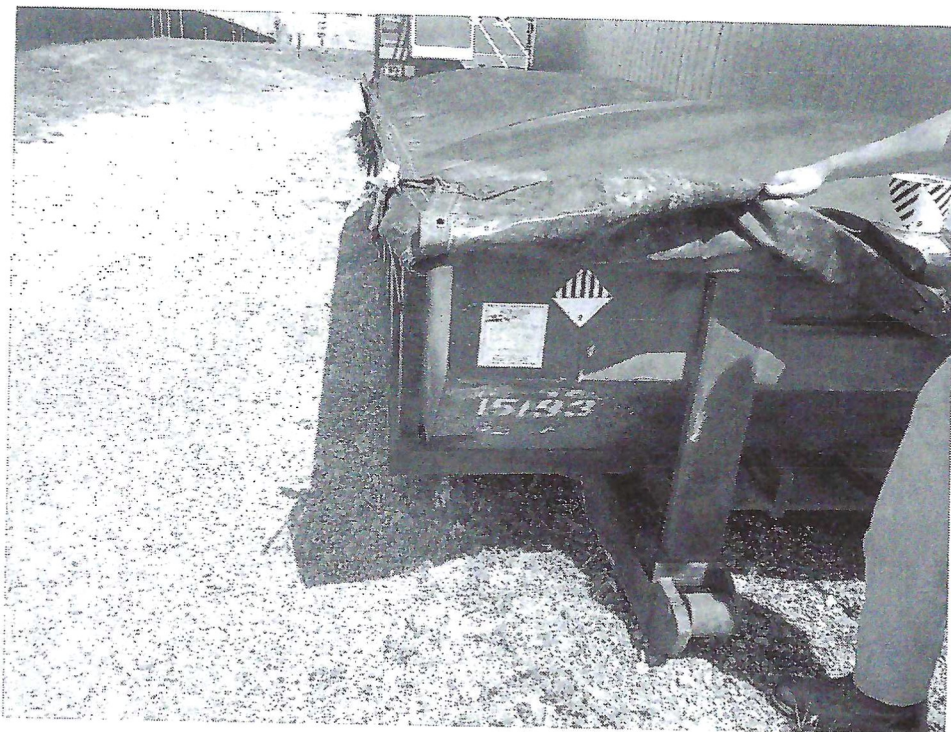
Bureau Id: 1191150002
Photo No.: 11
Photo Date: 6/21/2023
Photo Time: 2:56:55 PM
Direction: East
Taken By: Chris Cahnovsky

Properly labeled container.

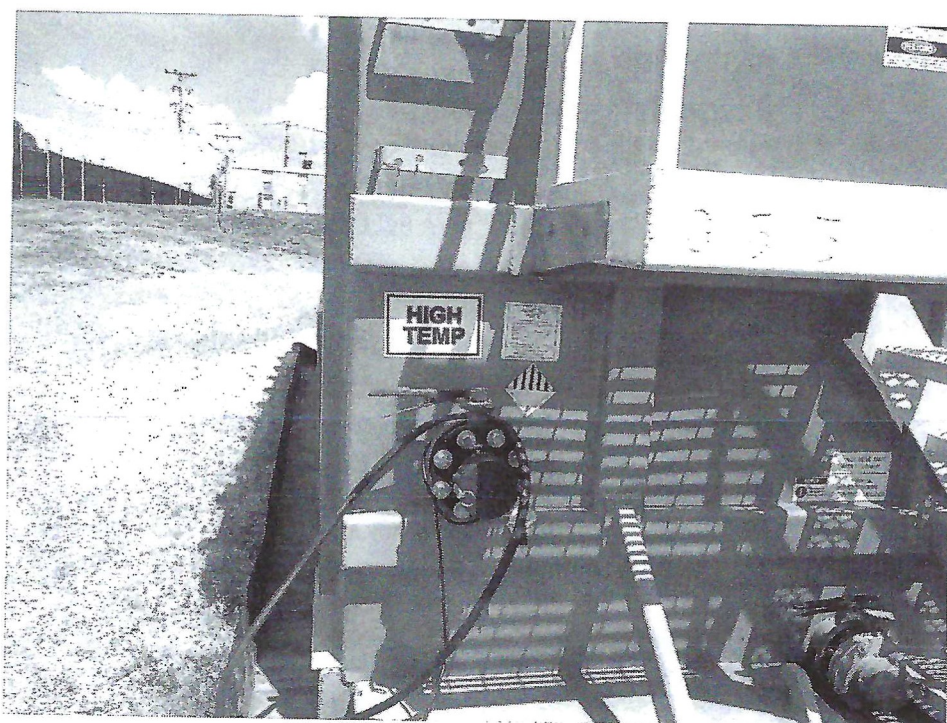
Bureau Id: 1191150002
Photo No.: 12
Photo Date: 6/21/2023
Photo Time: 2:57:35 PM
Direction: East
Taken By: Chris Cahnovsky

Properly labeled container.
