DISSOLVED PHASE  
GROUNDWATER  
INVESTIGATION AND P-60  
FREE PHASE PRODUCT  
DELINEATION

Roxana, Illinois

VOLUME II  
Appendix A - H

Dissolved Phase Groundwater Investigation and P-60 Free  
Phase Product Delineation  
**PHOTOGRAPHIC LOG**

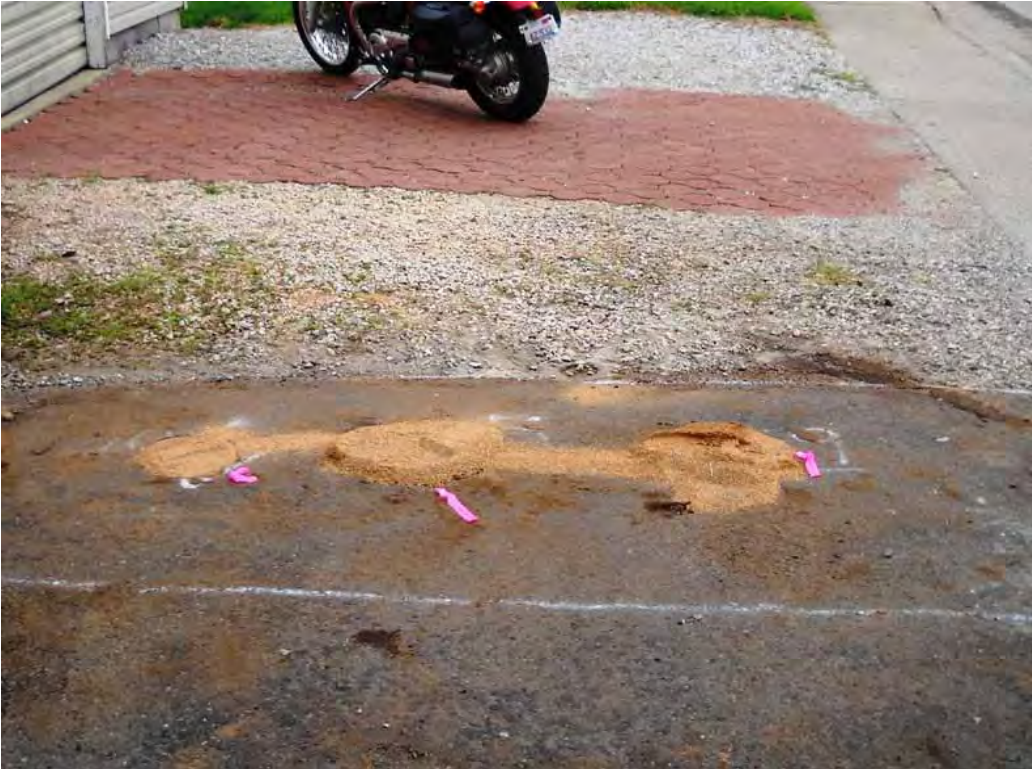
<b>Client Name:</b> Shell Oil Products US		<b>Site Location:</b> Roxana, Illinois	<b>Project No.</b> 21562289
<b>Photo No.</b> <b>3</b>	<b>Date:</b> 07/22/09

<b>Description:</b>  Locations ROST 9, GWP-7, and VMP-4 backfilled with sand after borehole clearance was completed and prior to drilling activities.

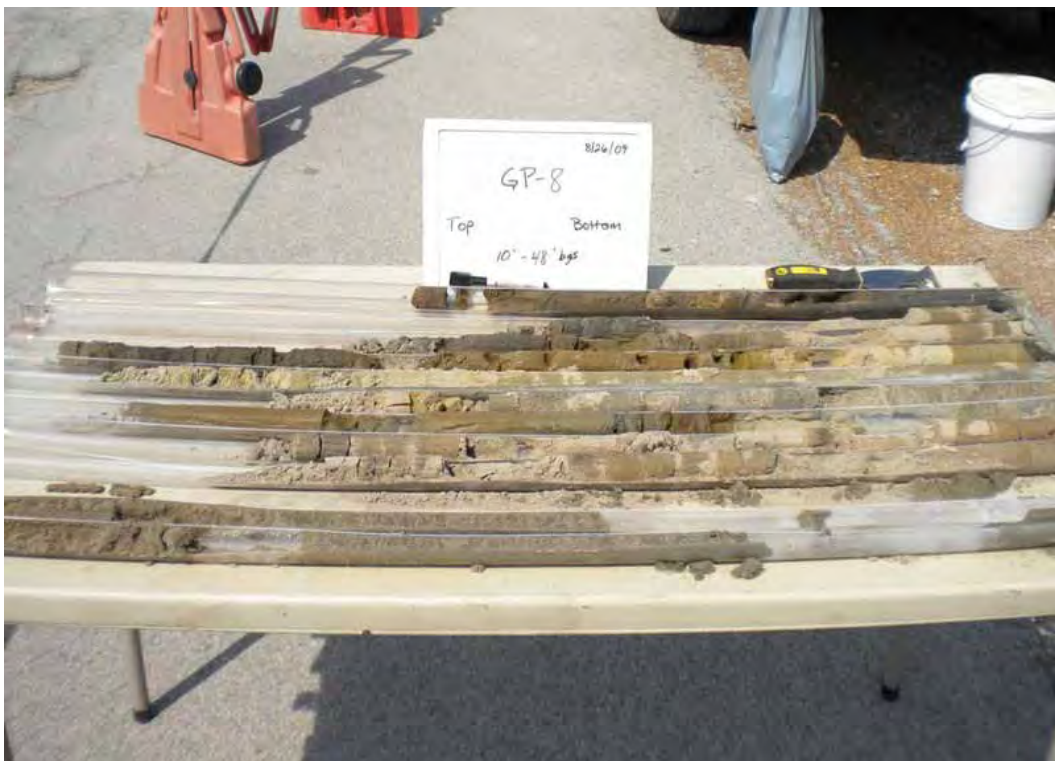
<b>Client Name:</b> Shell Oil Products US		<b>Site Location:</b> Roxana, Illinois	<b>Project No.</b> 21562289
<b>Photo No.</b> 7	<b>Date:</b> 08/24/09

<b>Description:</b>  Soil cores recovered during drilling and soil sampling activities at GP-8.

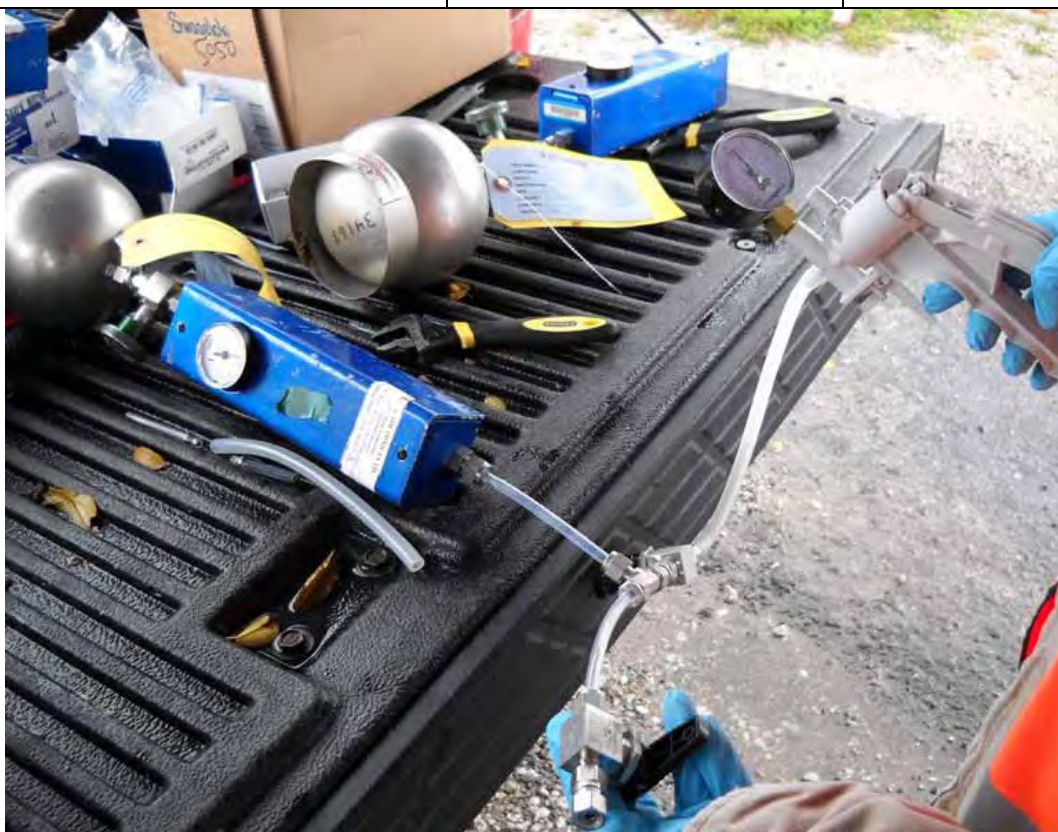
<b>Client Name:</b> Shell Oil Products US		<b>Site Location:</b> Roxana, Illinois	<b>Project No.</b> 21562289
<b>Photo No.</b> <b>15</b>	<b>Date:</b> 10/27/09

<b>Description:</b>  Leak testing performed on the sample train prior to sampling of vapor port.

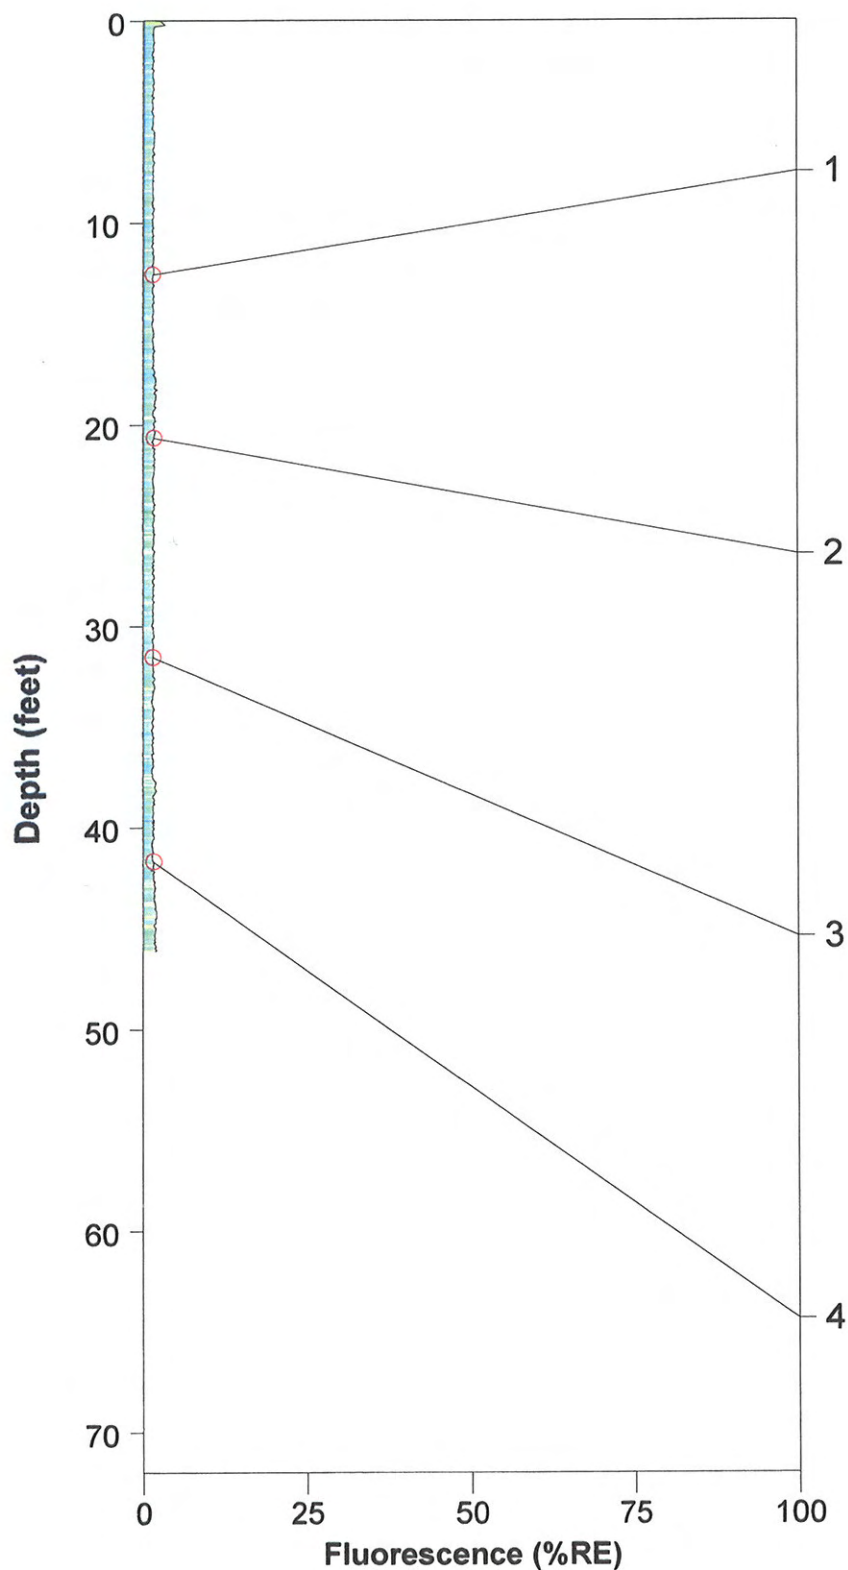
## ROST-01

# ROST Fluorescence Response Data

Site: Conoco-Roxana, IL	Operator: Robert Biehle
Client: URS	Fugro Job #: 04.1909-0044
Date/Time: 8/27/2009 @ 9:16:44 AM	Max fluorescence: 2.23% @ 0.35 ft
ROST Unit: Houston	Final depth BGS: 46.11 ft

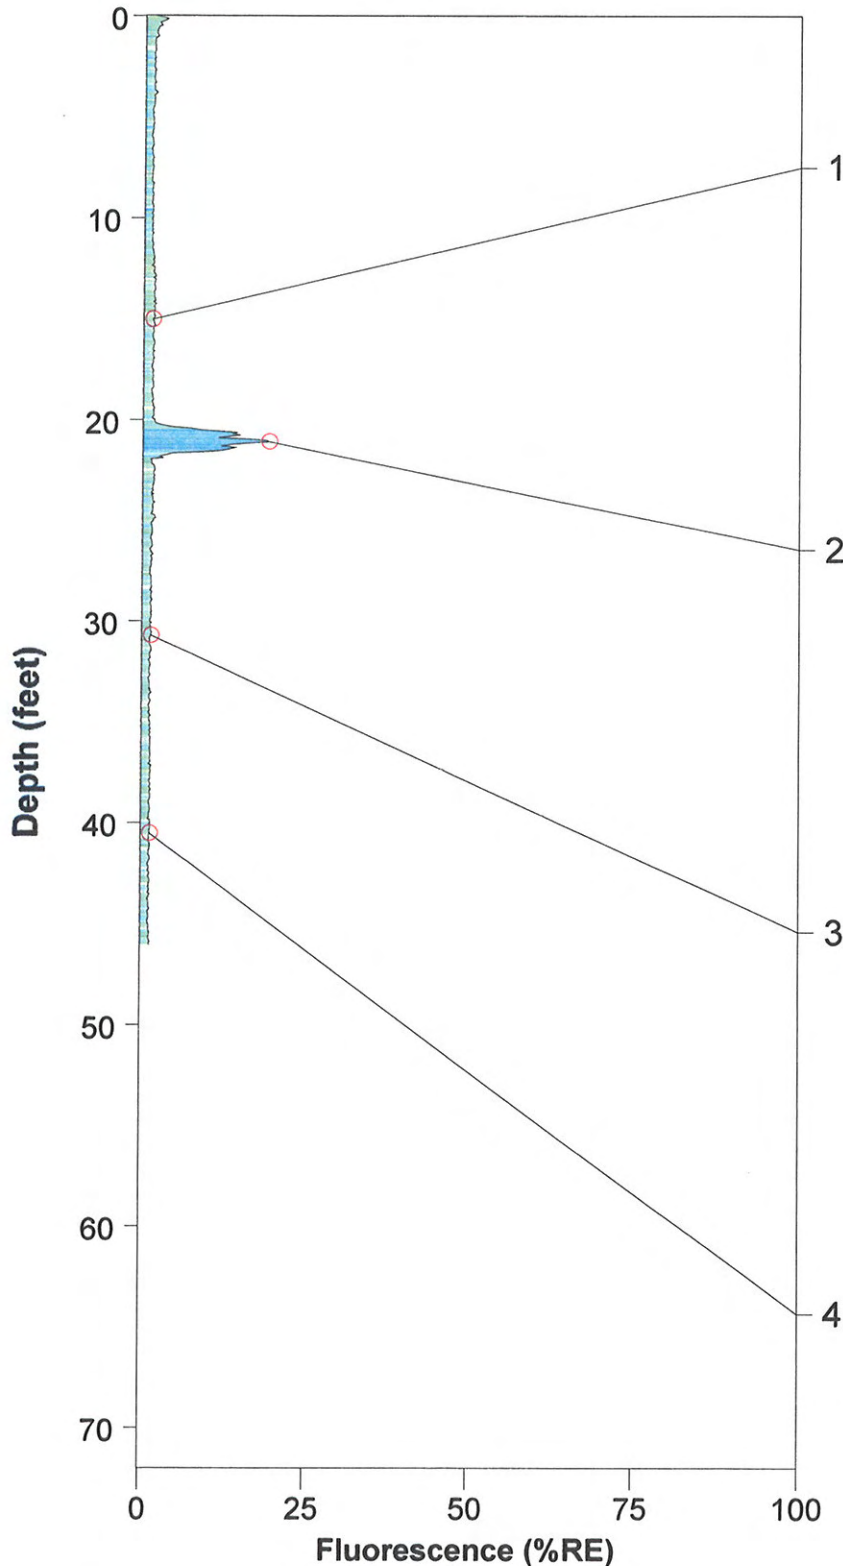
## ROST-09

# ROST Fluorescence Response Data

Site: Conoco-Roxana, IL	Operator: Robert Biehle
Client: URS	Fugro Job #: 04.1909-0044
Date/Time: 8/26/2009 @ 12:14:11 PM	Max fluorescence: 13.79% @ 50.16 ft
ROST Unit: Houston	Final depth BGS: 50.16 ft
