**Subject: SVE System Construction Completion Report Addendum  
Equilon Enterprises LLC d/b/a Shell Oil Products US  
Roxana, Illinois  
1191150002 -- Madison County  
ILD 080 012 305  
Log No. B-43R**

SVE SYSTEM CONSTRUCTION  
COMPLETION REPORT  
ADDENDUM

WRB REFINING LP  
WOOD RIVER REFINERY  
ROXANA, ILLINOIS

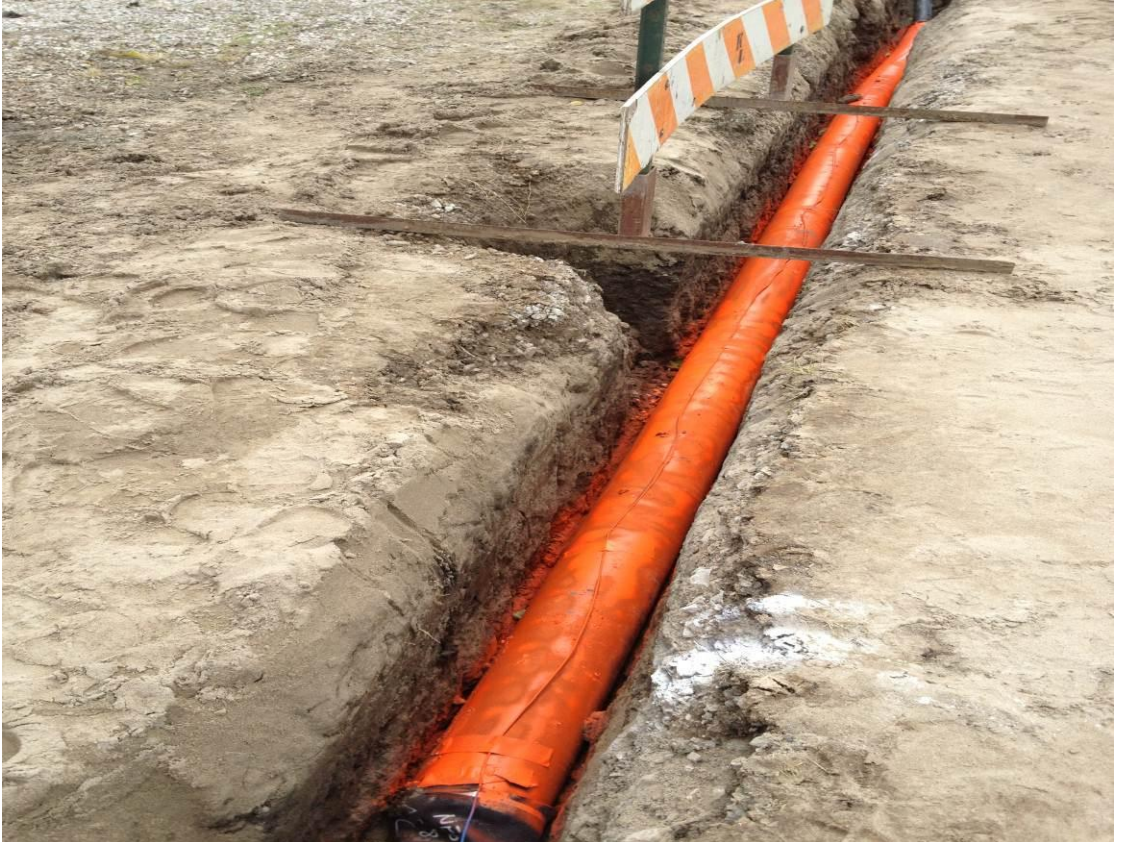
<b>Client Name:</b> Shell		<b>Site Location:</b> Shell SVE System- Public Works Property	<b>Project No.</b> 21562850.12000
<b>Photo No.</b> <b>3</b>	<b>Date</b> 10/25/12

<b>Description:</b> Looking southwest at installation of the 4" diameter HDPE SVE pipe placed within a 8" diameter HDPE protective casing pipe in the location of underground utilities. Protective pipe casings were painted orange and tracer wire was installed the full length of the SVE piping.

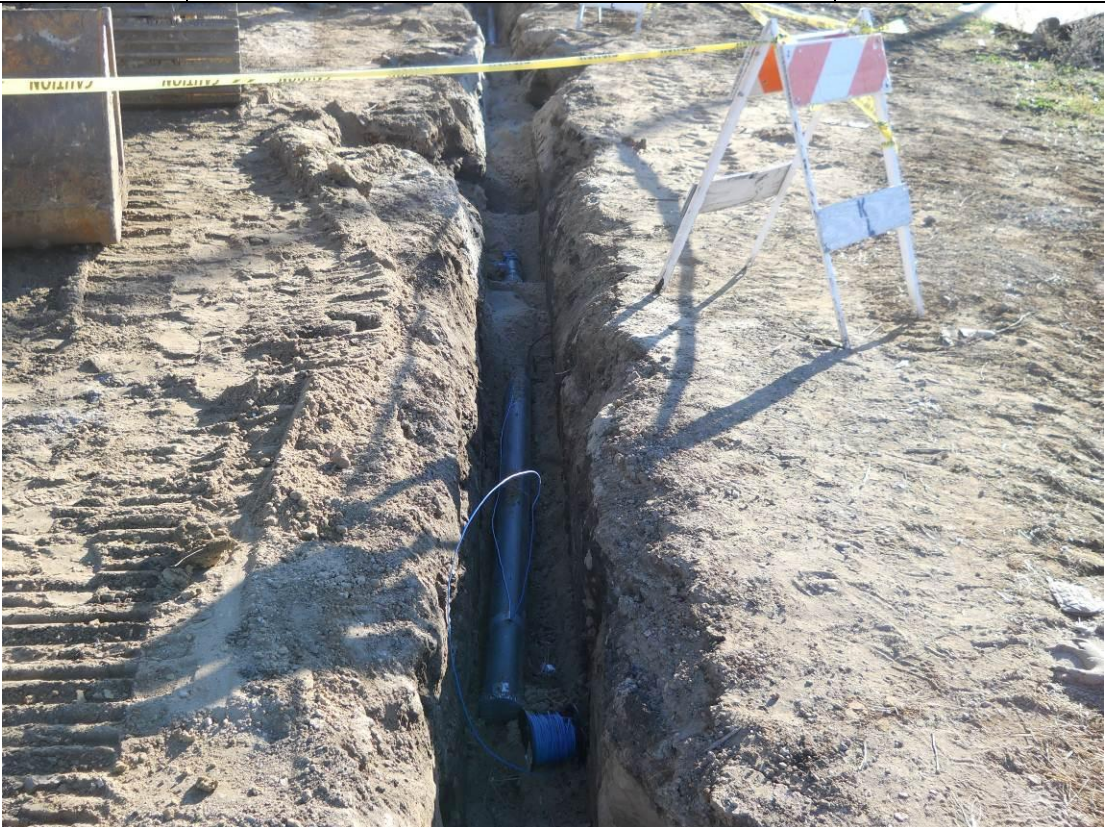
<b>Client Name:</b> Shell		<b>Site Location:</b> Shell SVE System- Public Works Property	<b>Project No.</b> 21562850.12000
<b>Photo No.</b> <b>7</b>	<b>Date</b> 10/31/12

<b>Description:</b> Facing east, looking at the excavation and installation of the SVE piping to the south of the vault for SVE-27.

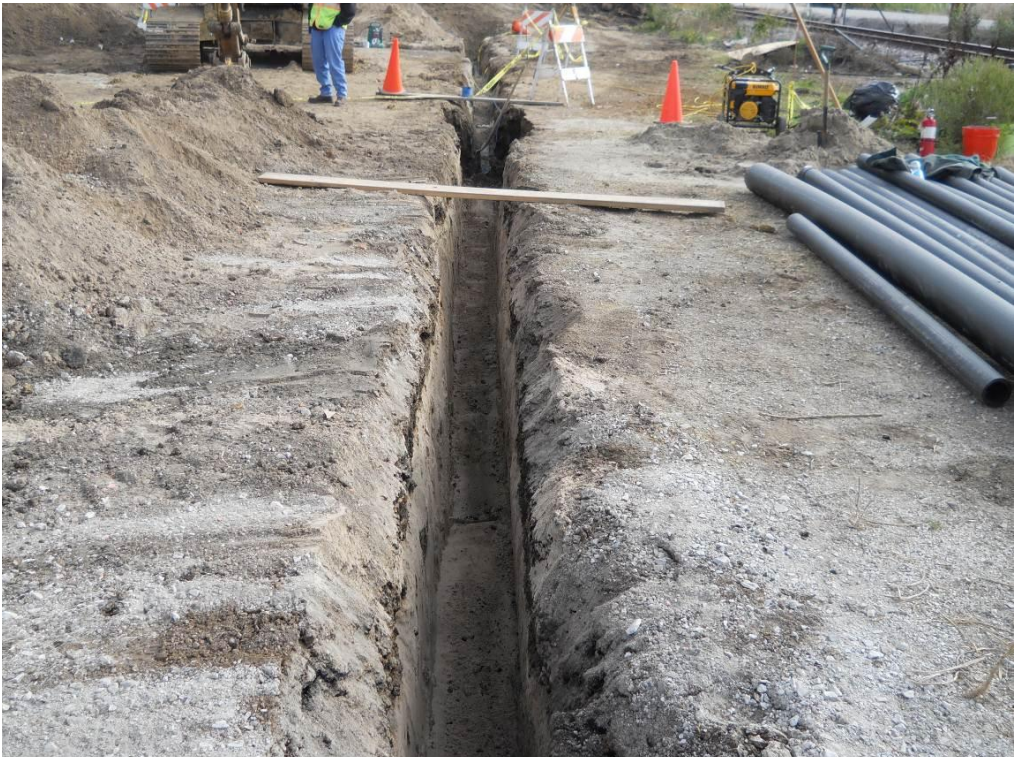
<b>Photo No.</b> <b>10</b>	<b>Date</b> 11/1/12

<b>Description:</b> Facing east, looking at the excavation and installation of the SVE piping to the southwest of the vault for SVE- 27

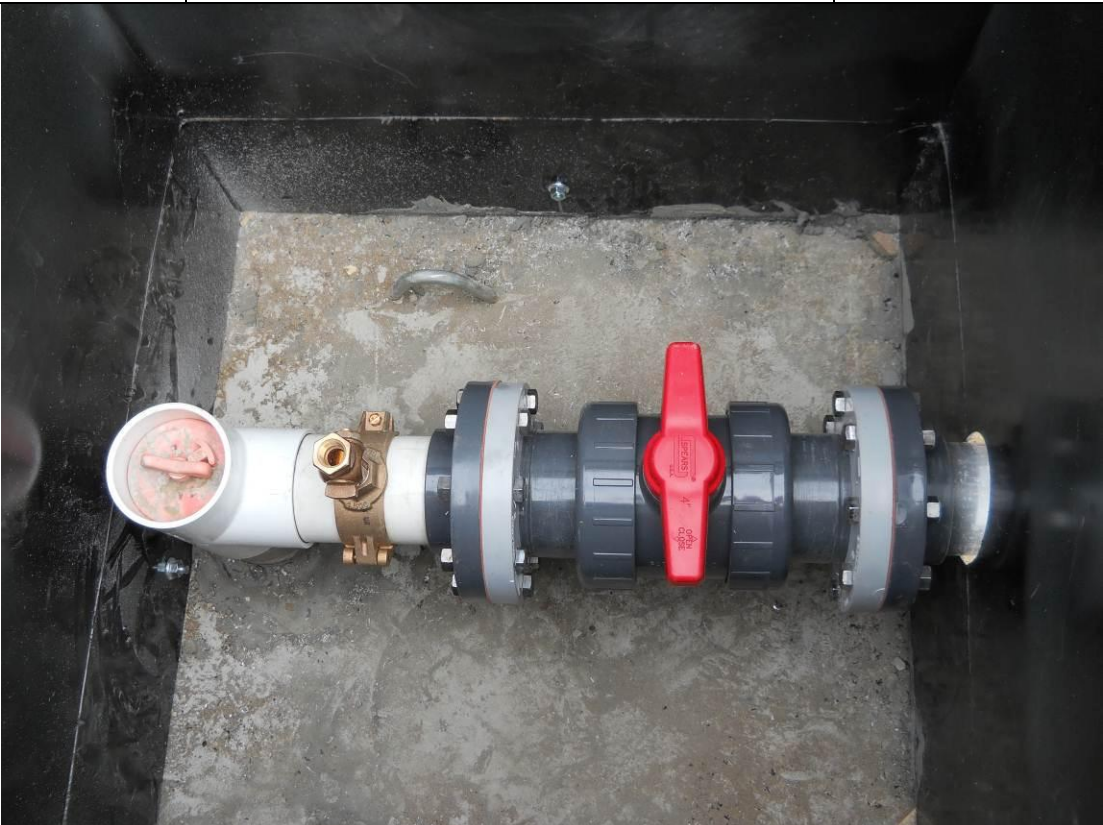
<b>Client Name:</b> Shell		<b>Site Location:</b> Shell SVE System- Public Works Property	<b>Project No.</b> 21562850.12000
<b>Photo No.</b> <b>11</b>	<b>Date</b> 11/1/12

<b>Description:</b> Looking inside the vault for SVE-27.

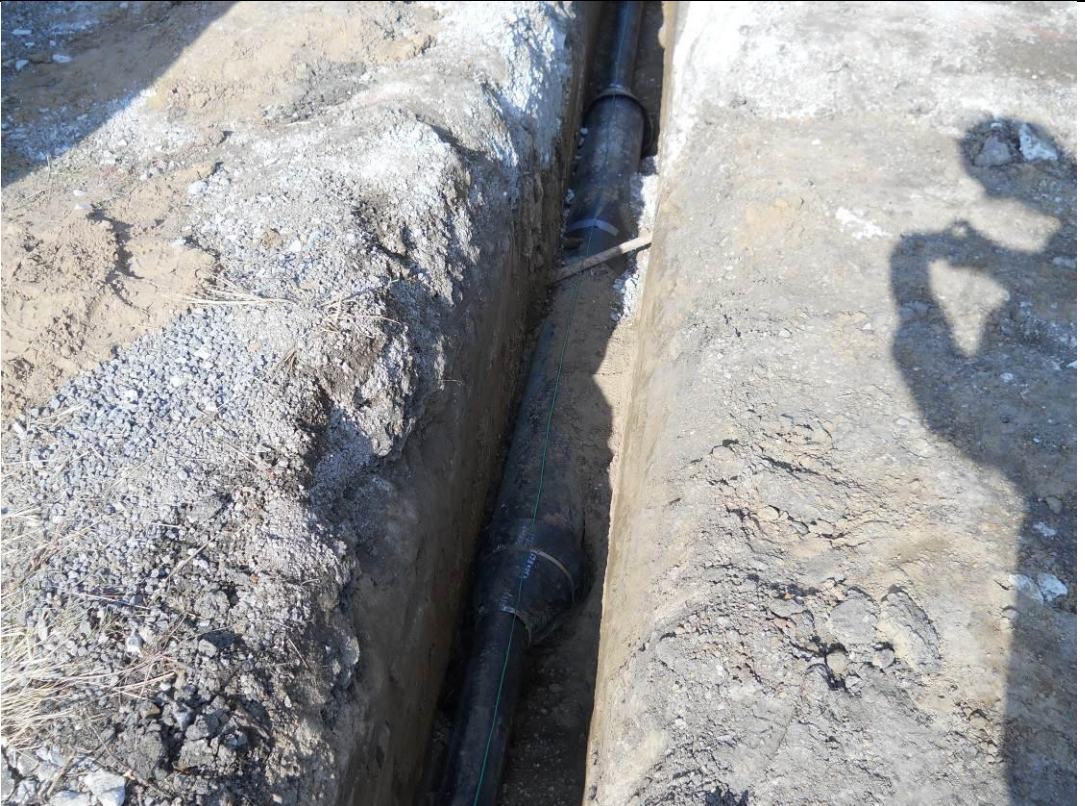
<b>Client Name:</b> Shell		<b>Site Location:</b> Shell SVE System- Public Works Property	<b>Project No.</b> 21562850.12000
<b>Photo No.</b> <b>13</b>	<b>Date</b> 11/9/12

<b>Description:</b> Looking north at the installation of the 4" diameter HDPE SVE pipe and an 8" diameter HDPE protective pipe casing placed below an electrical conduit servicing the Public Works equipment fuel tank.

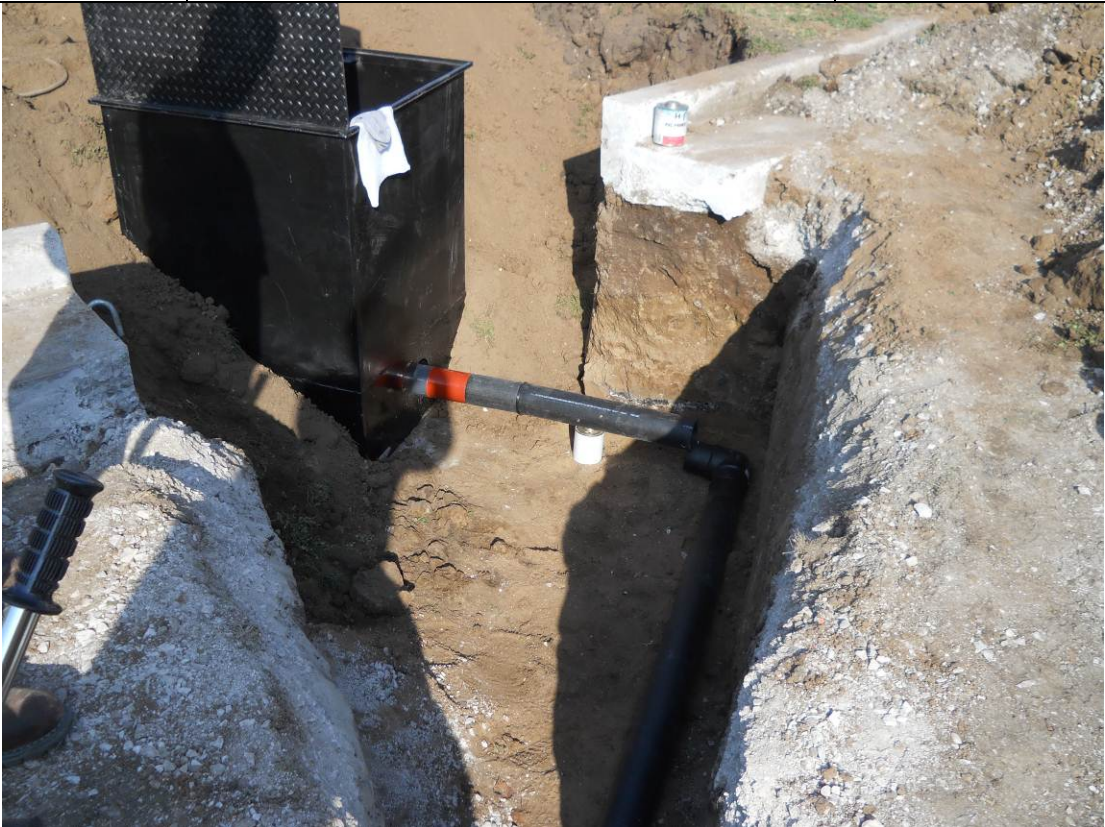
<b>Client Name:</b> Shell		<b>Site Location:</b> Shell SVE System- Public Works Property	<b>Project No.</b> 21562850.12000
<b>Photo No.</b> <b>15</b>	<b>Date</b> 11/9/12

<b>Description:</b> Installation of vault for SVE-21. Facing north.

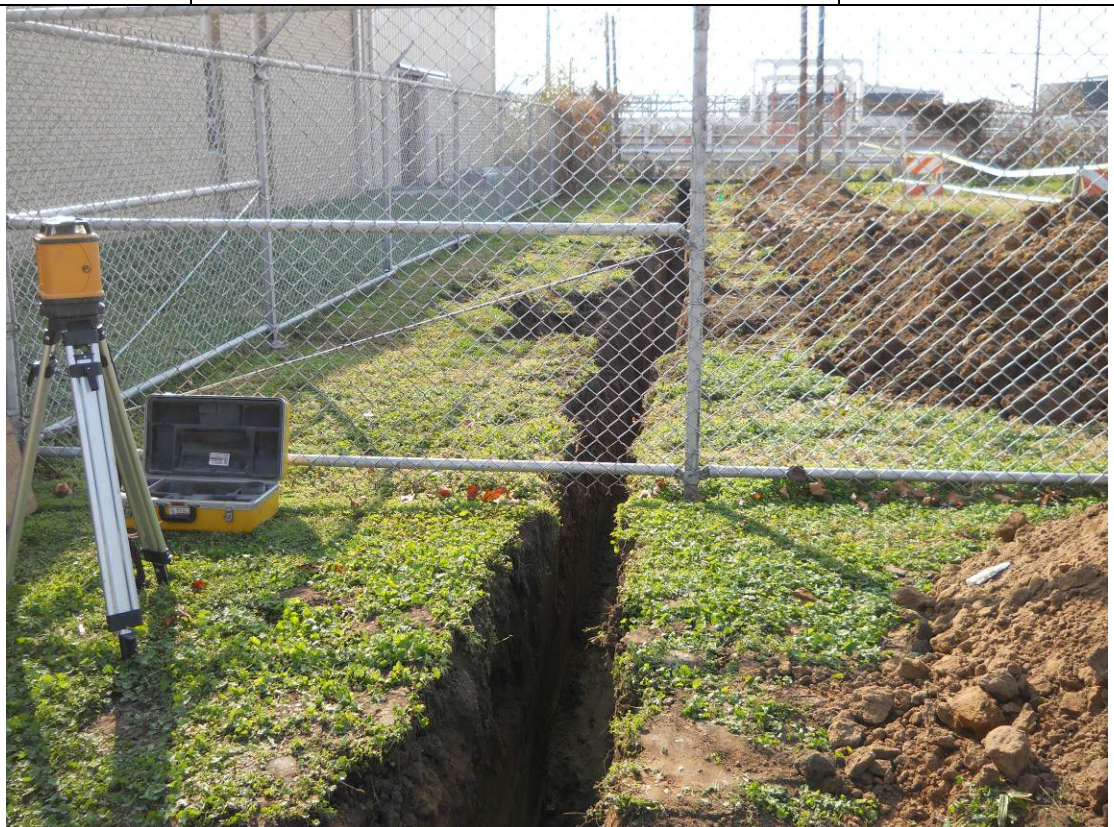
<b>Client Name:</b> Shell		<b>Site Location:</b> Shell SVE System- Public Works Property	<b>Project No.</b> 21562850.12000
<b>Photo No.</b> <b>17</b>	<b>Date</b> 11/9/12

<b>Description:</b> Excavation for the SVE piping from the vault for SVE-21. Facing south.

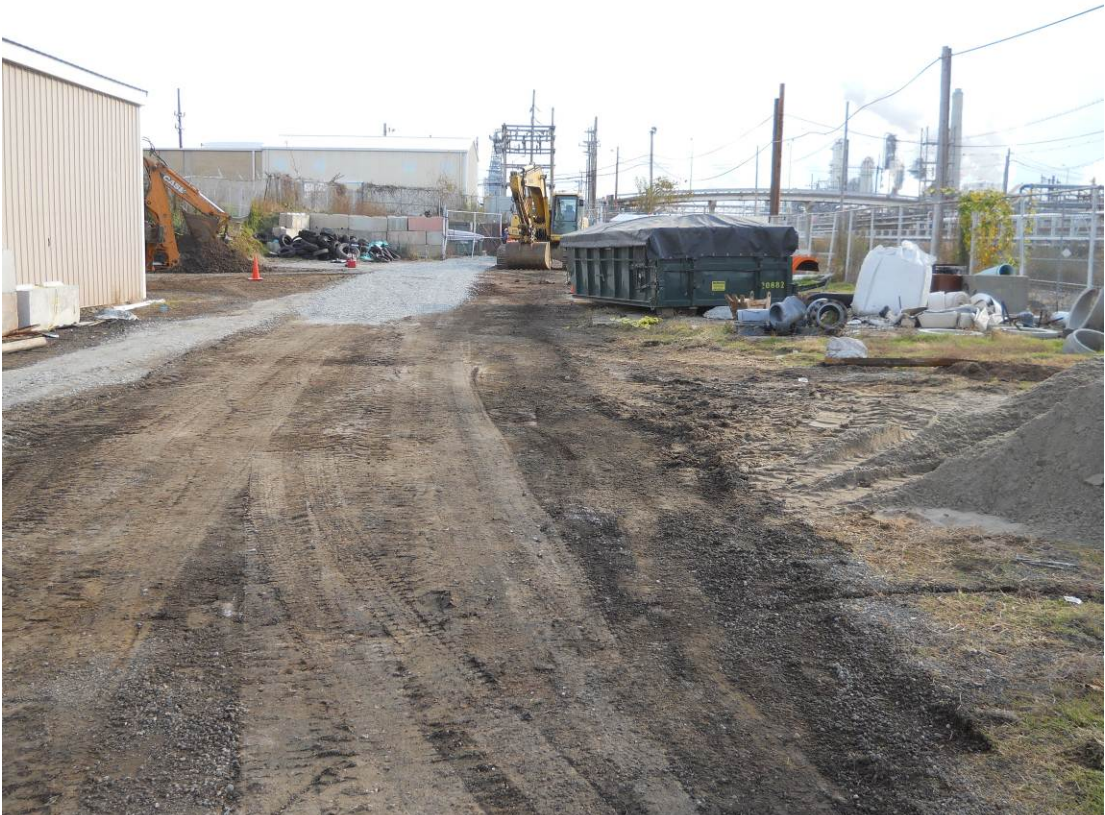
<b>Photo No.</b> <b>20</b>	<b>Date</b> 11/14/12

<b>Description:</b> Grading and resurfacing the Public Works roadway from the southwest entrance gate eastward to the back gate. Facing east.

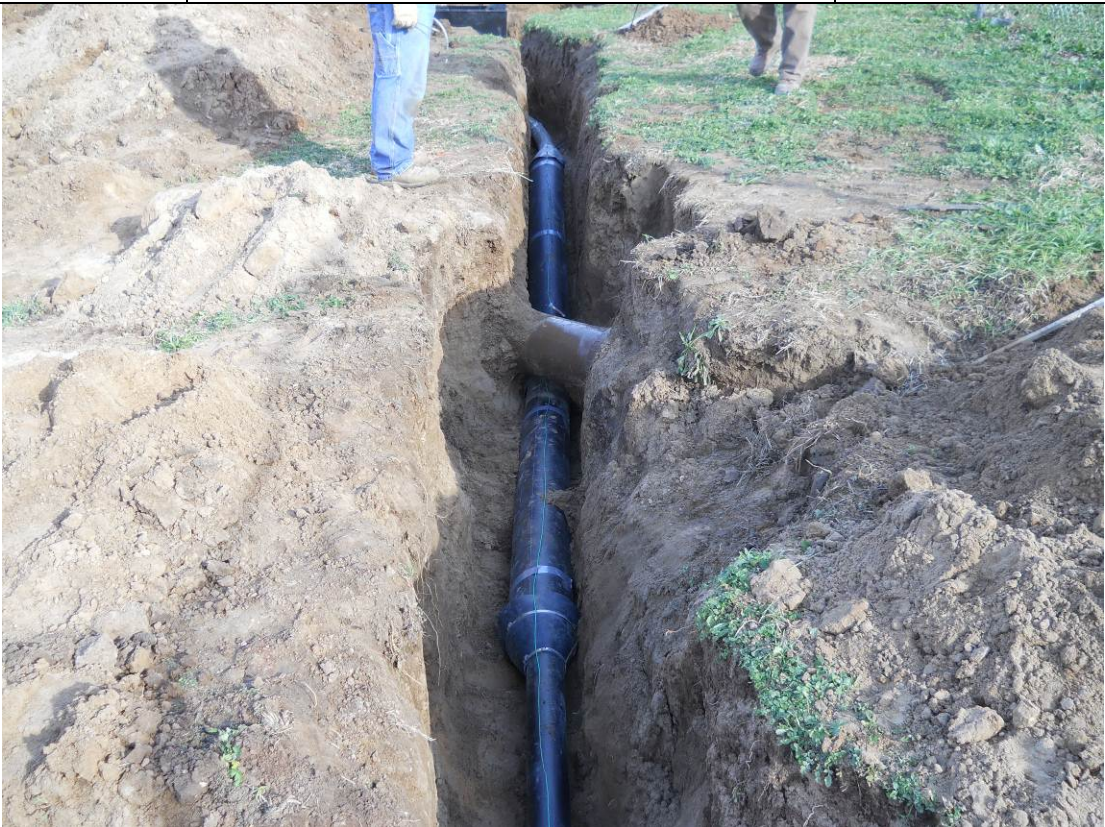
<b>Client Name:</b> Shell		<b>Site Location:</b> Shell SVE System- Public Works Property	<b>Project No.</b> 21562850.12000
<b>Photo No.</b> <b>21</b>	<b>Date</b> 11/14/12

<b>Description:</b> Looking north at the 8" dia HDPE protective pipe casing installed just below a clay tile sewer pipe.

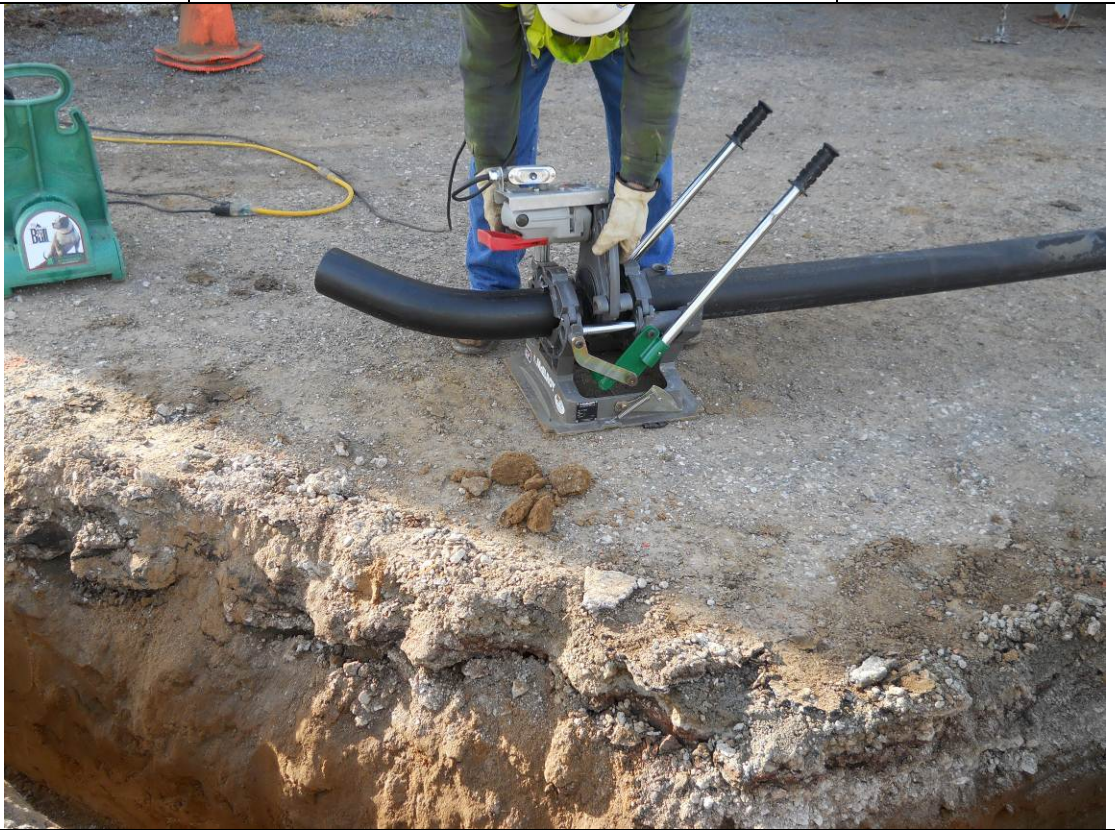
Preparation of 4" diameter HDPE pipe to be fusion welded.

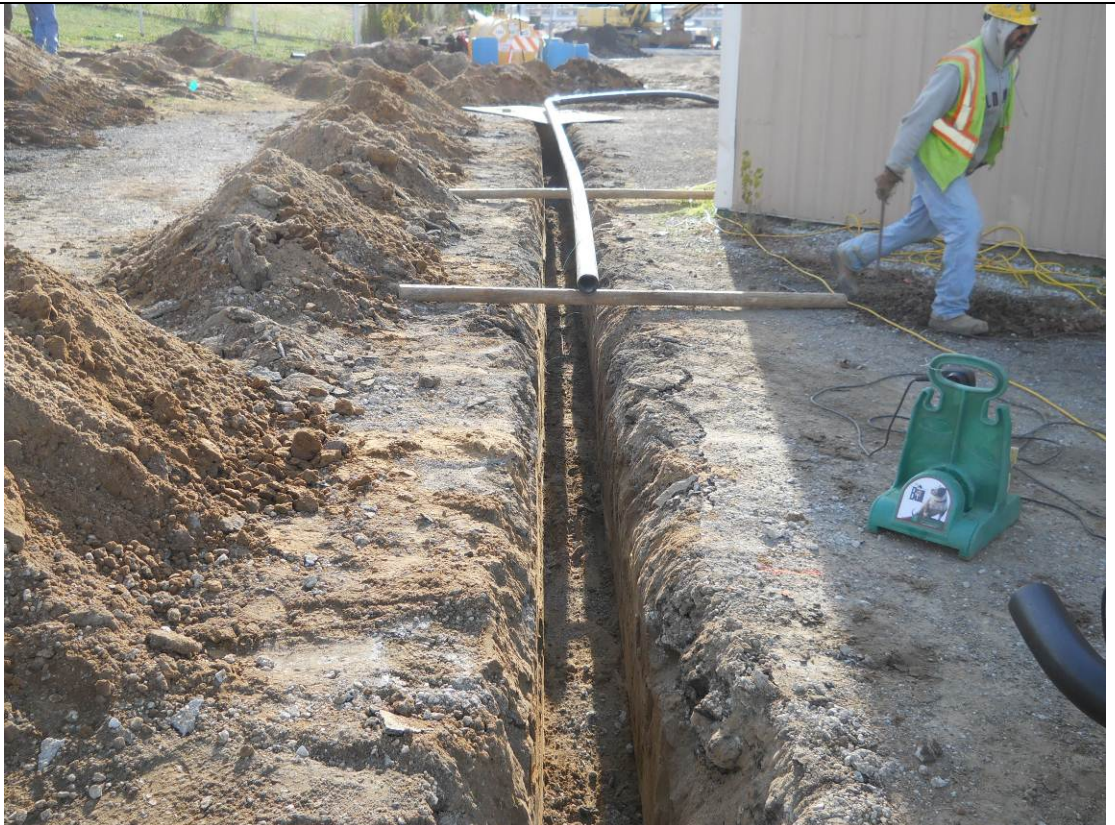
**24**

Fabrication and installation of the 4" diameter HDPE SVE pipeline from vault at SVE-22 to vault at SVE-23. Facing southeast.

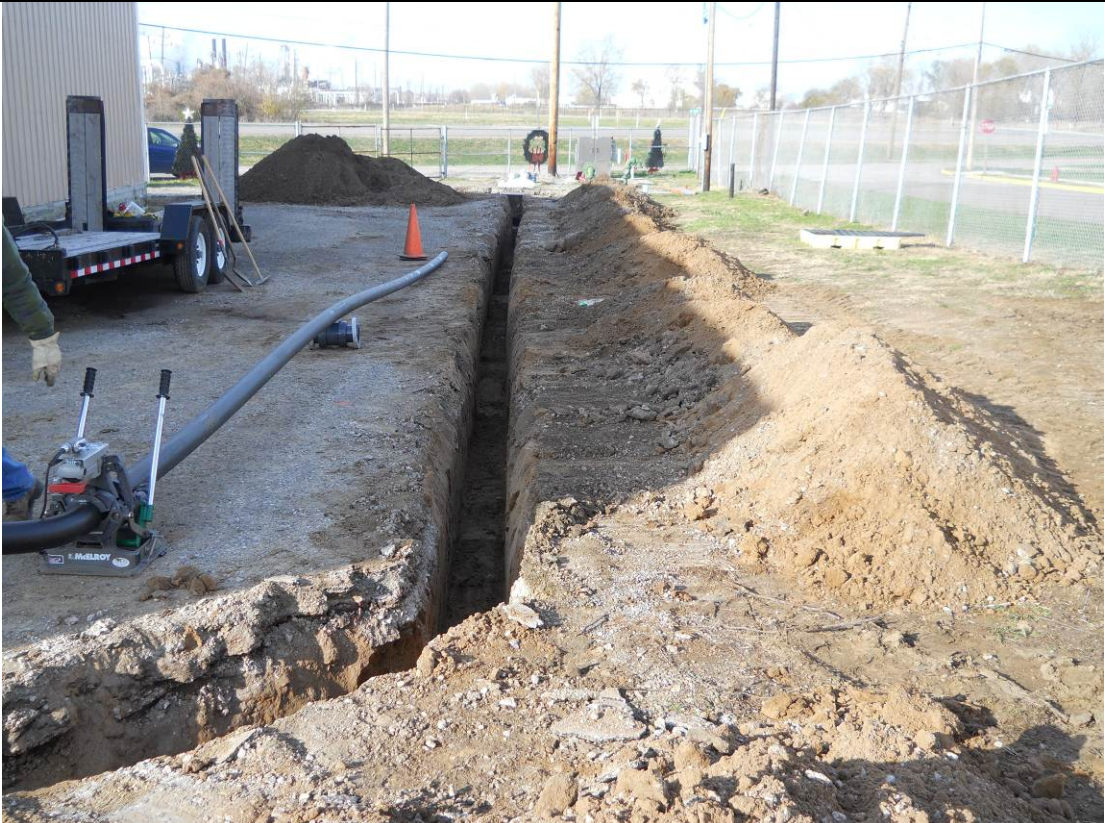
<b>Client Name:</b> Shell		<b>Site Location:</b> Shell SVE System- Public Works Property	<b>Project No.</b> 21562850.12000
<b>Photo No.</b> <b>25</b>	<b>Date</b> 11/14/12

<b>Description:</b> Fabrication and installation of the 4" diameter HDPE SVE pipeline from vault at SVE-22 to vault at SVE-23. Facing west.

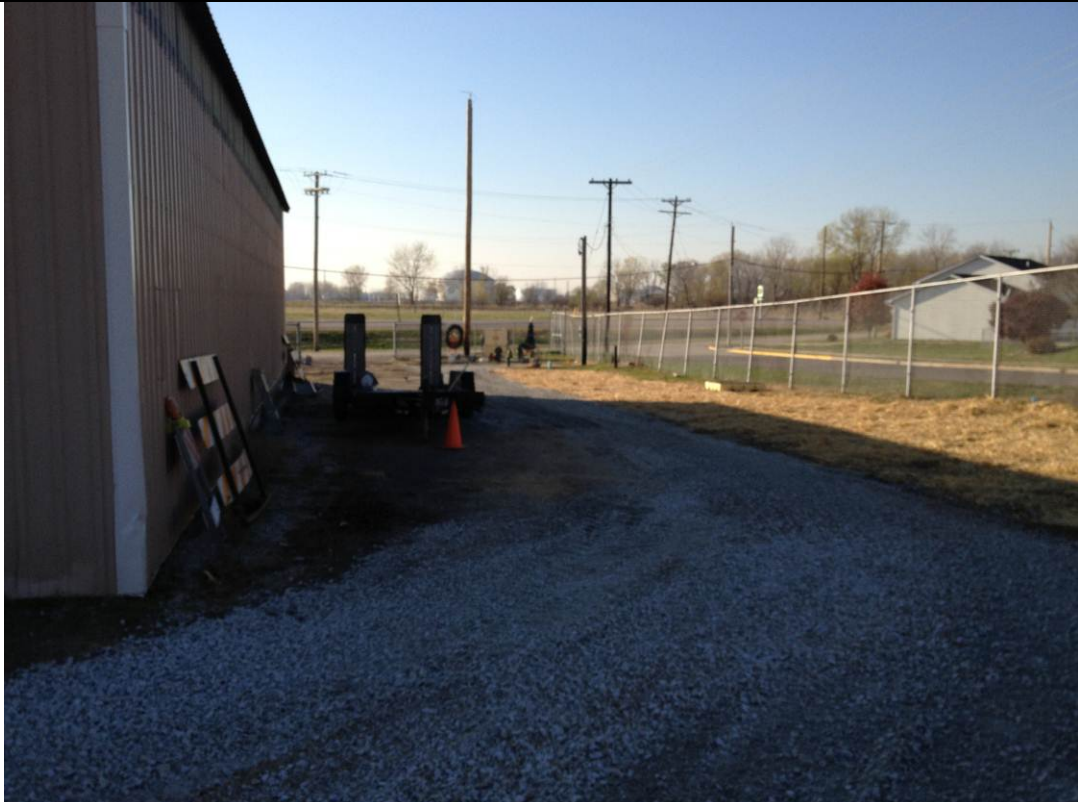
<b>Photo No.</b> <b>26</b>	<b>Date</b> 11/16/12

<b>Description:</b> Grading and resurfacing the Public Works roadway from the northwest entrance gate eastward along the north side of the Public Works buildings. Facing west.

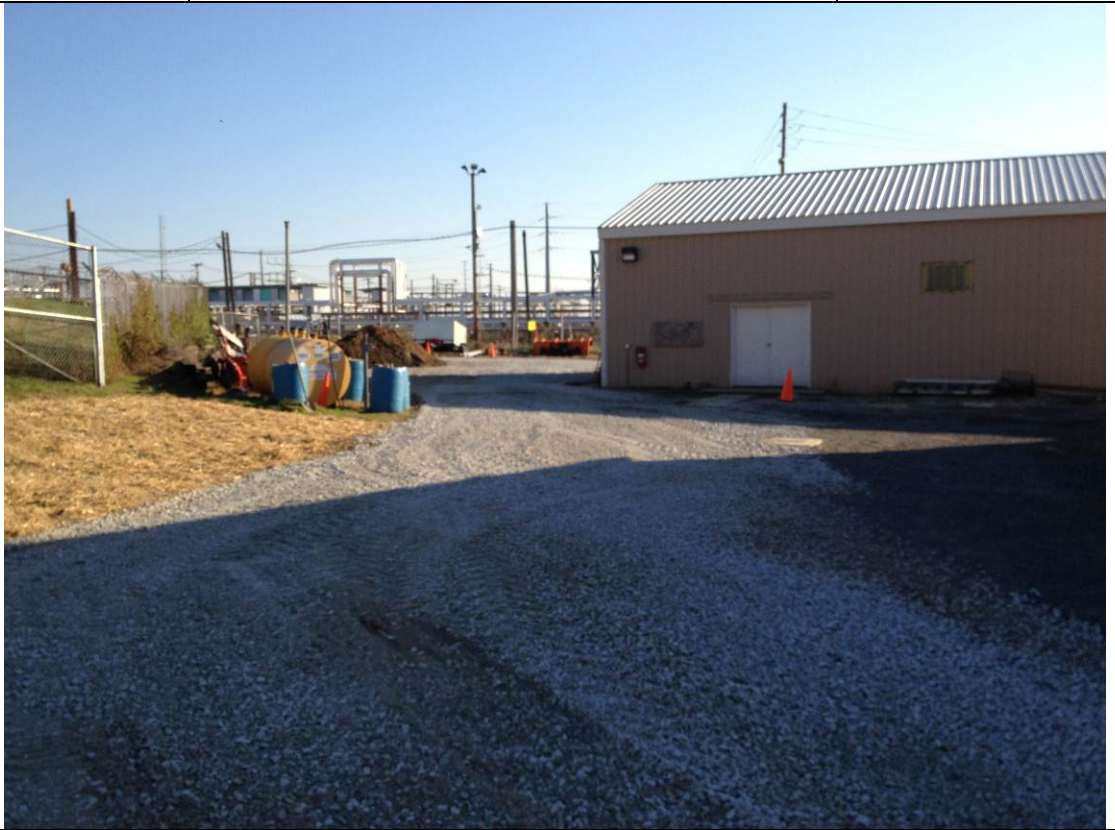
Grading and resurfacing the Public Works roadway from SVE-22 south to SVE-26 along the east sides of the Public Works buildings. Facing south.

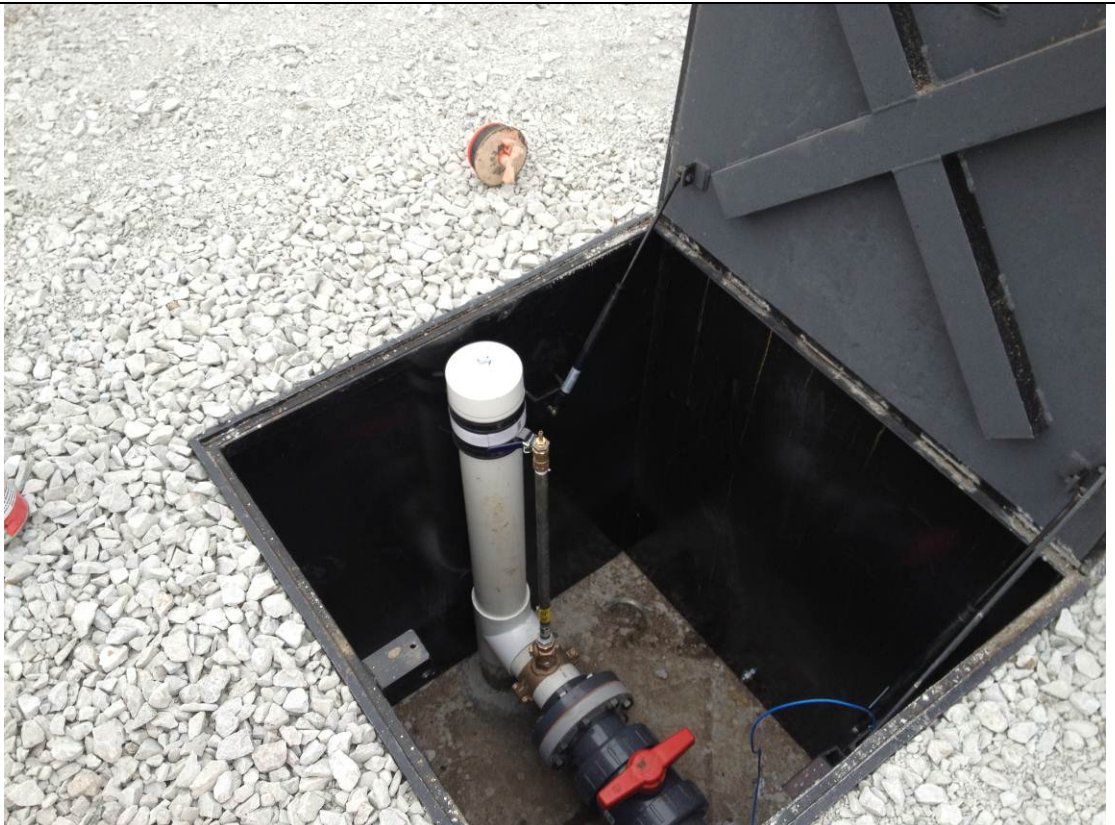
**28**

Installation of vault at SVE-23. Facing north.

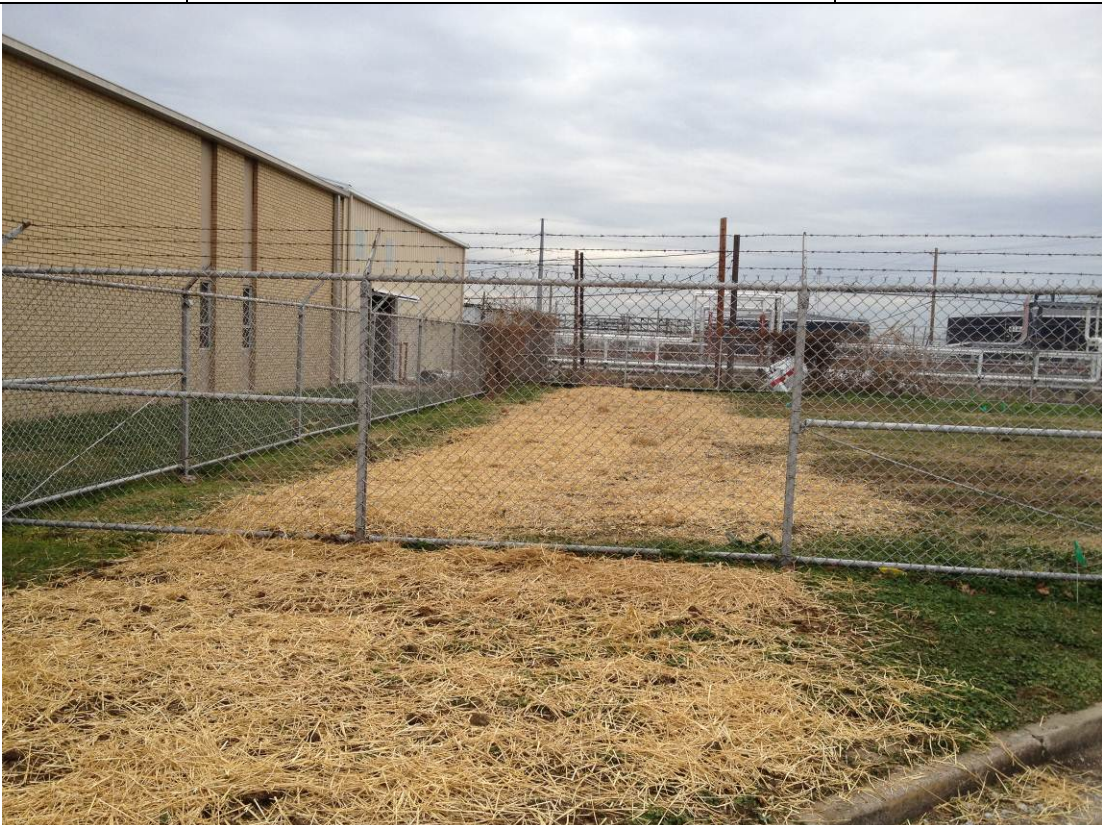
<b>Client Name:</b> Shell		<b>Site Location:</b> Shell SVE System- Public Works Property	<b>Project No.</b> 21562850.12000
<b>Photo No.</b> <b>29</b>	<b>Date</b> 11/19/12

<b>Description:</b> Finished grade with seed/straw along SVE pipe trench excavation running south from SVE-21. Facing south.
