**Subject: Soil Vapor Extraction Pilot Test Report
Roxana, Illinois
119115002 – Madison County
Equilon Enterprises LLC d/b/a Shell Oil Products US
Log No. B-43-CA-16 and 18**

On behalf of Shell Oil Products US, URS Corporation is submitting the enclosed pilot test report for your review. This report was developed in response to the Agency's letter dated March 15, 2011.

As requested by condition 8 in the Agency's March 16, 2011 letter, this report summarizes the results of the pilot tests.

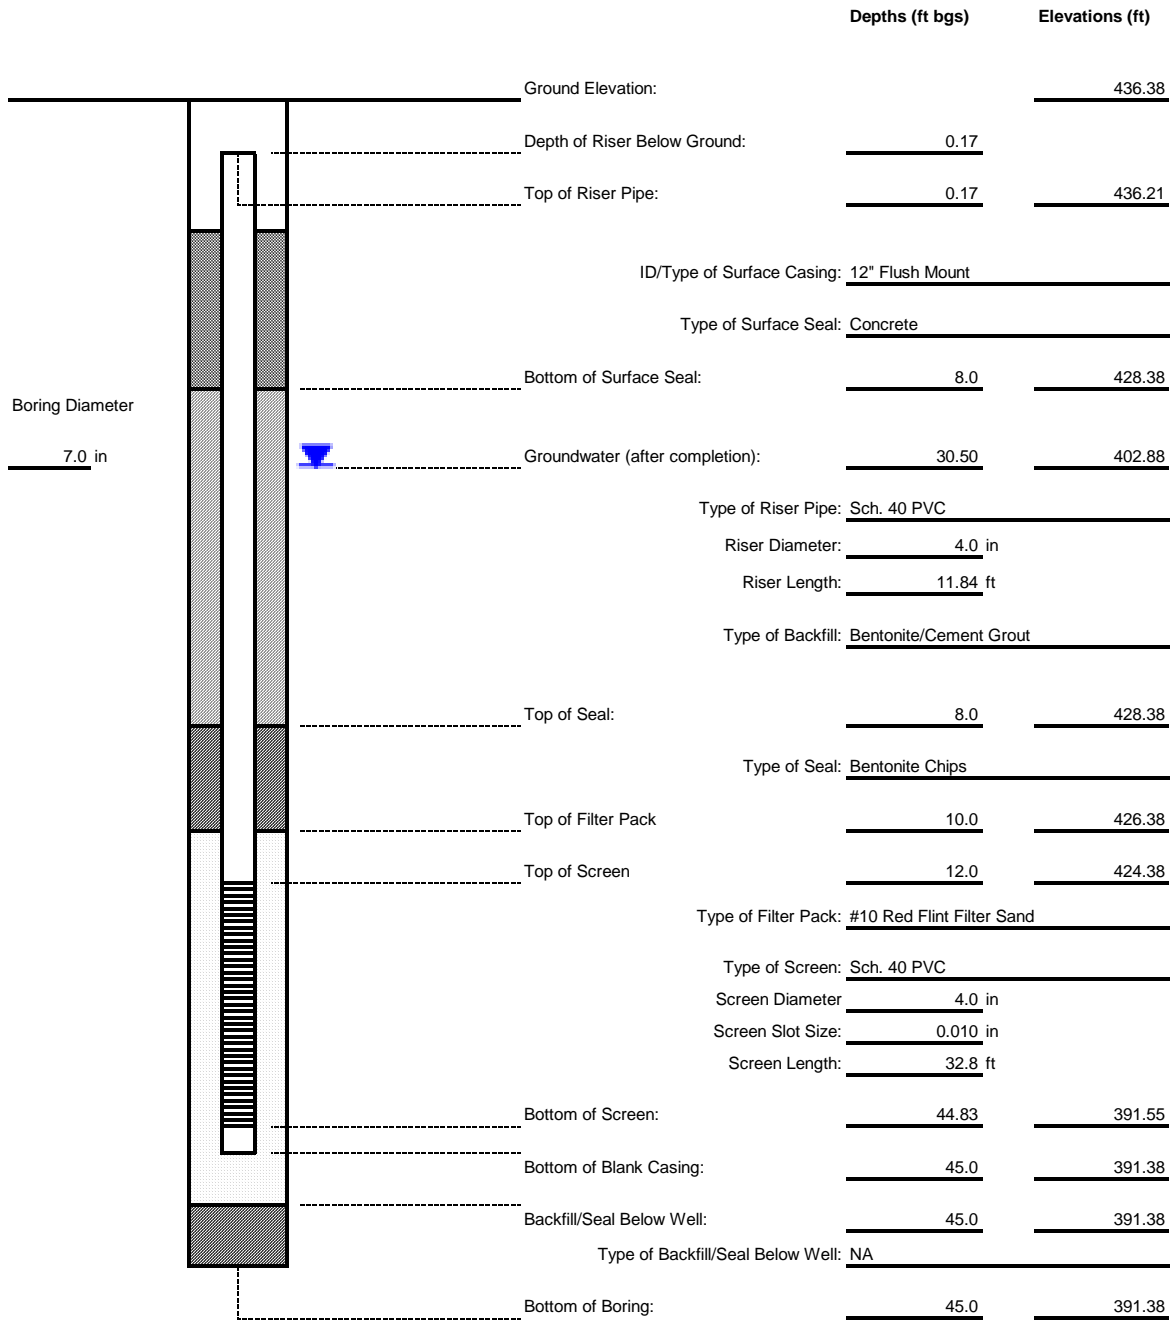
VAPOR MONITORING POINT CONSTRUCTION DIAGRAM

Project:	Roxana SVE Pilot Test			Well ID:	SVE-2
Project Location:	Roxana, Illinois	Date Started:	3/2/2011		
Well Location:	Roxana, Illinois	Date Completed:	3/2/2011	Boring ID:	NA
Drilling Contractor:	Boart Longyear	Time Seal Set:	1220	Northing:	791987.449
Driller:		Type of Rig:		Easting:	2322012.145
Consulting Firm:	URS Corporation	Drilling Method:	Roto Sonic	Elevation Datum:	436.38
Geologist:	M. Miller	Completion Zone:	Main Stratum

DIAGRAM IS NOT TO SCALE

The SVE extraction wells were first air knifed to a depth of 10 feet below ground surface (bgs) to ensure underground utilities were cleared and then were drilled by Boart Longyear using rotasonic drilling technology. Once the bore holes were drilled, the wells were installed with 4-inch diameter PVC and the base of the screens were set at a depth at or near the water table under low water level conditions (approximately 55 and 45 feet bgs along the west fence line and at Public Works respectively). The filter pack was installed in one foot lifts that extends to approximately 2-feet above the top of the screen. A three foot thick bentonite chip seal was installed immediately above the sand pack in one foot lifts with each lift being hydrated and the remaining annular space was filled with a cement bentonite grout. During SVE extraction well installation activities soil samples were collected from SVE-1 (11-12 ft. and 53-54 ft. bgs) and SVE-2 (11-12 ft. and 33-34 ft. bgs) for analytical testing.

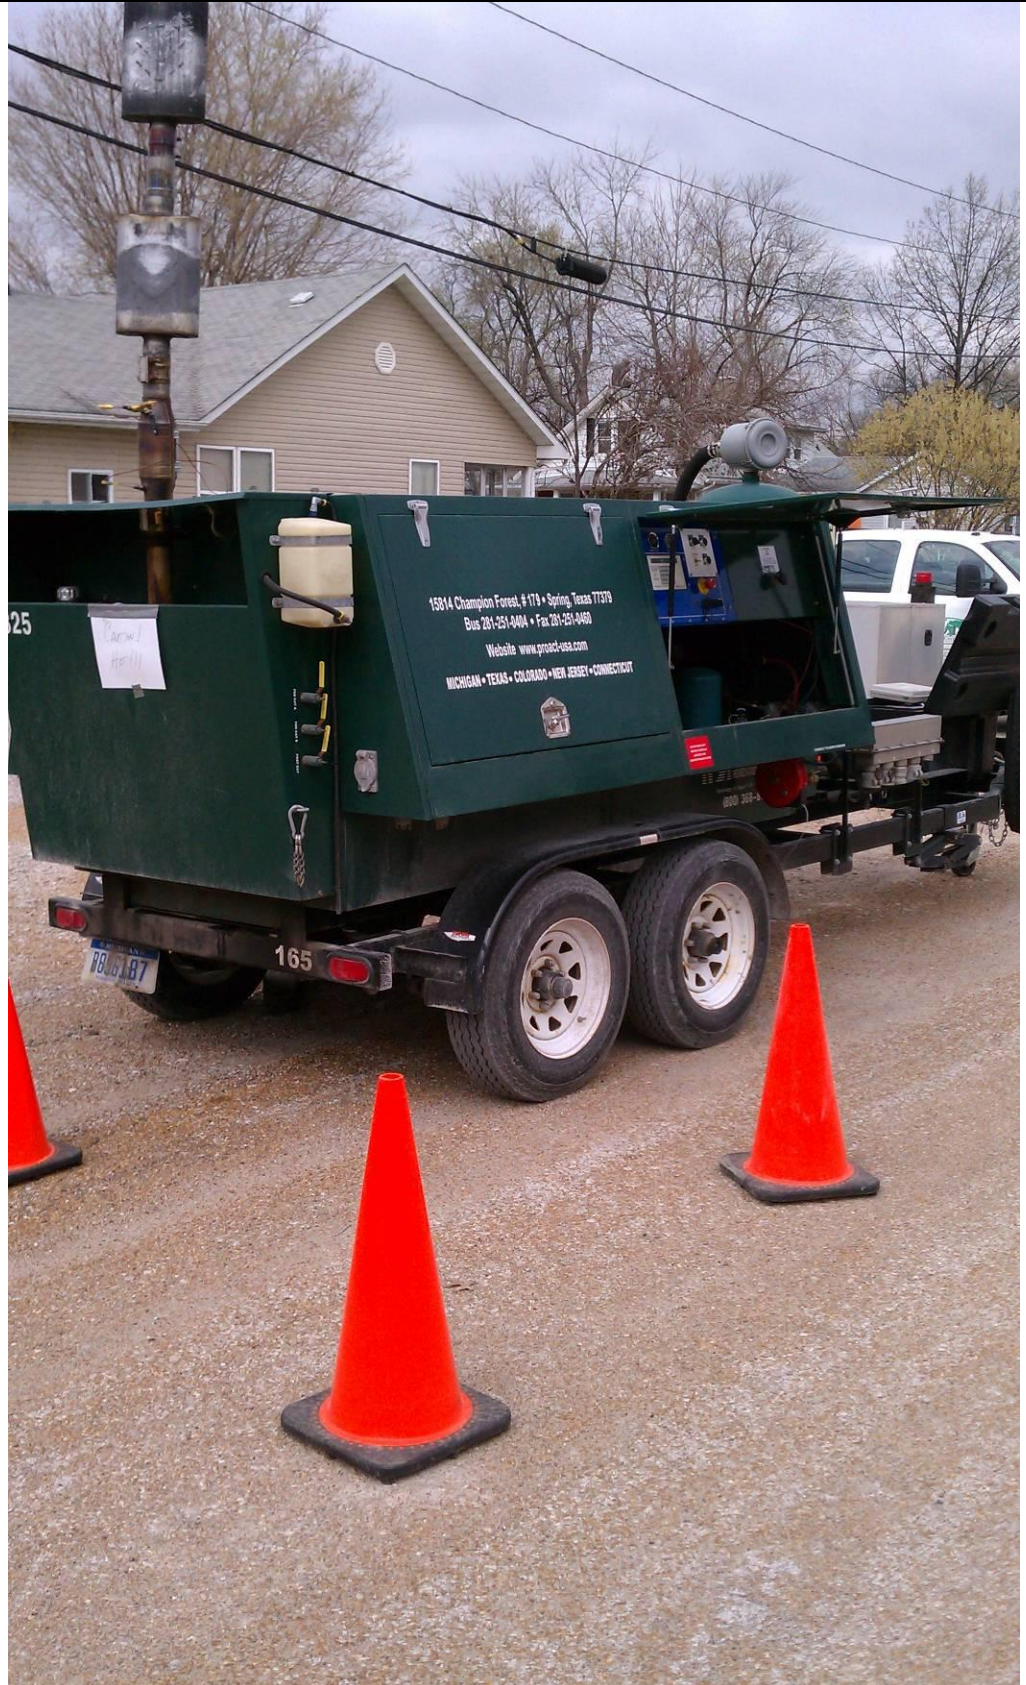
ICE Unit –
Illustrating control
panel and muffler
system for
additional noise
reduction due to
close proximity to
residential areas.

The ICE operation is controlled by several site specific factors including: soil moisture, O₂ and CO₂ content in the soil, and soil vapor constituent concentrations available from the extraction well. The PLC controls the air flow from well based on a maximum hydrocarbon influent flow rate of 36 lb/hr.

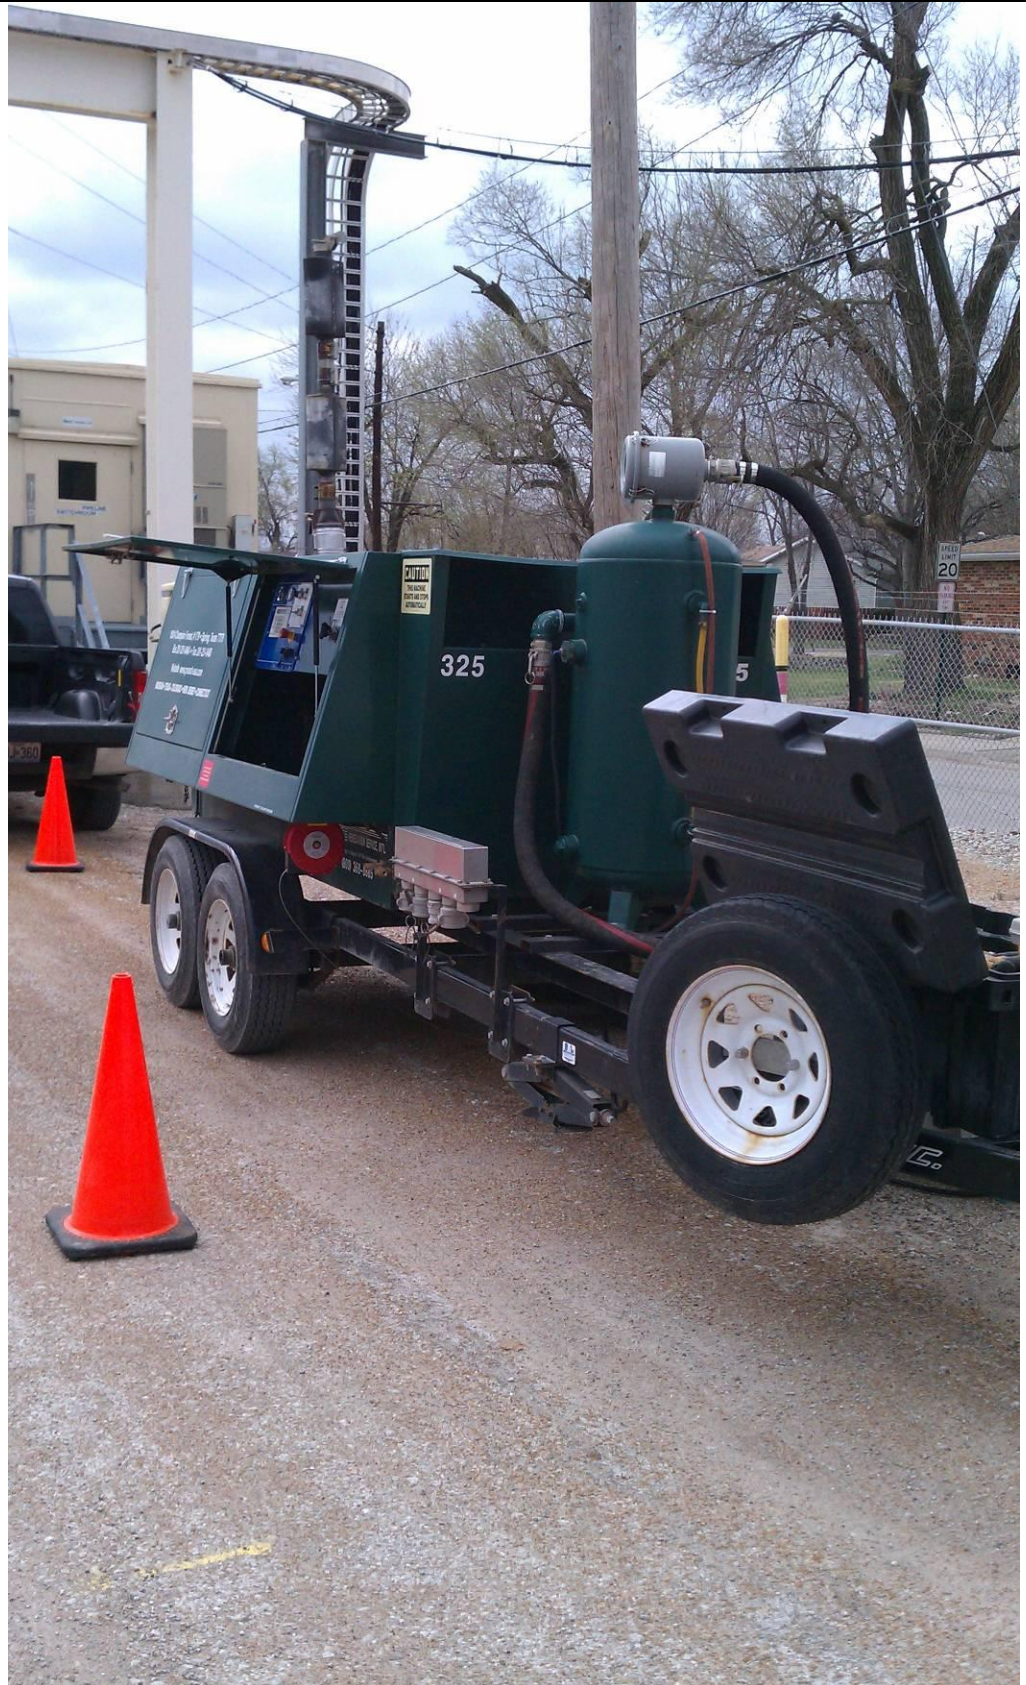
ICE Unit –
Illustrating residual
water knock out
tank.

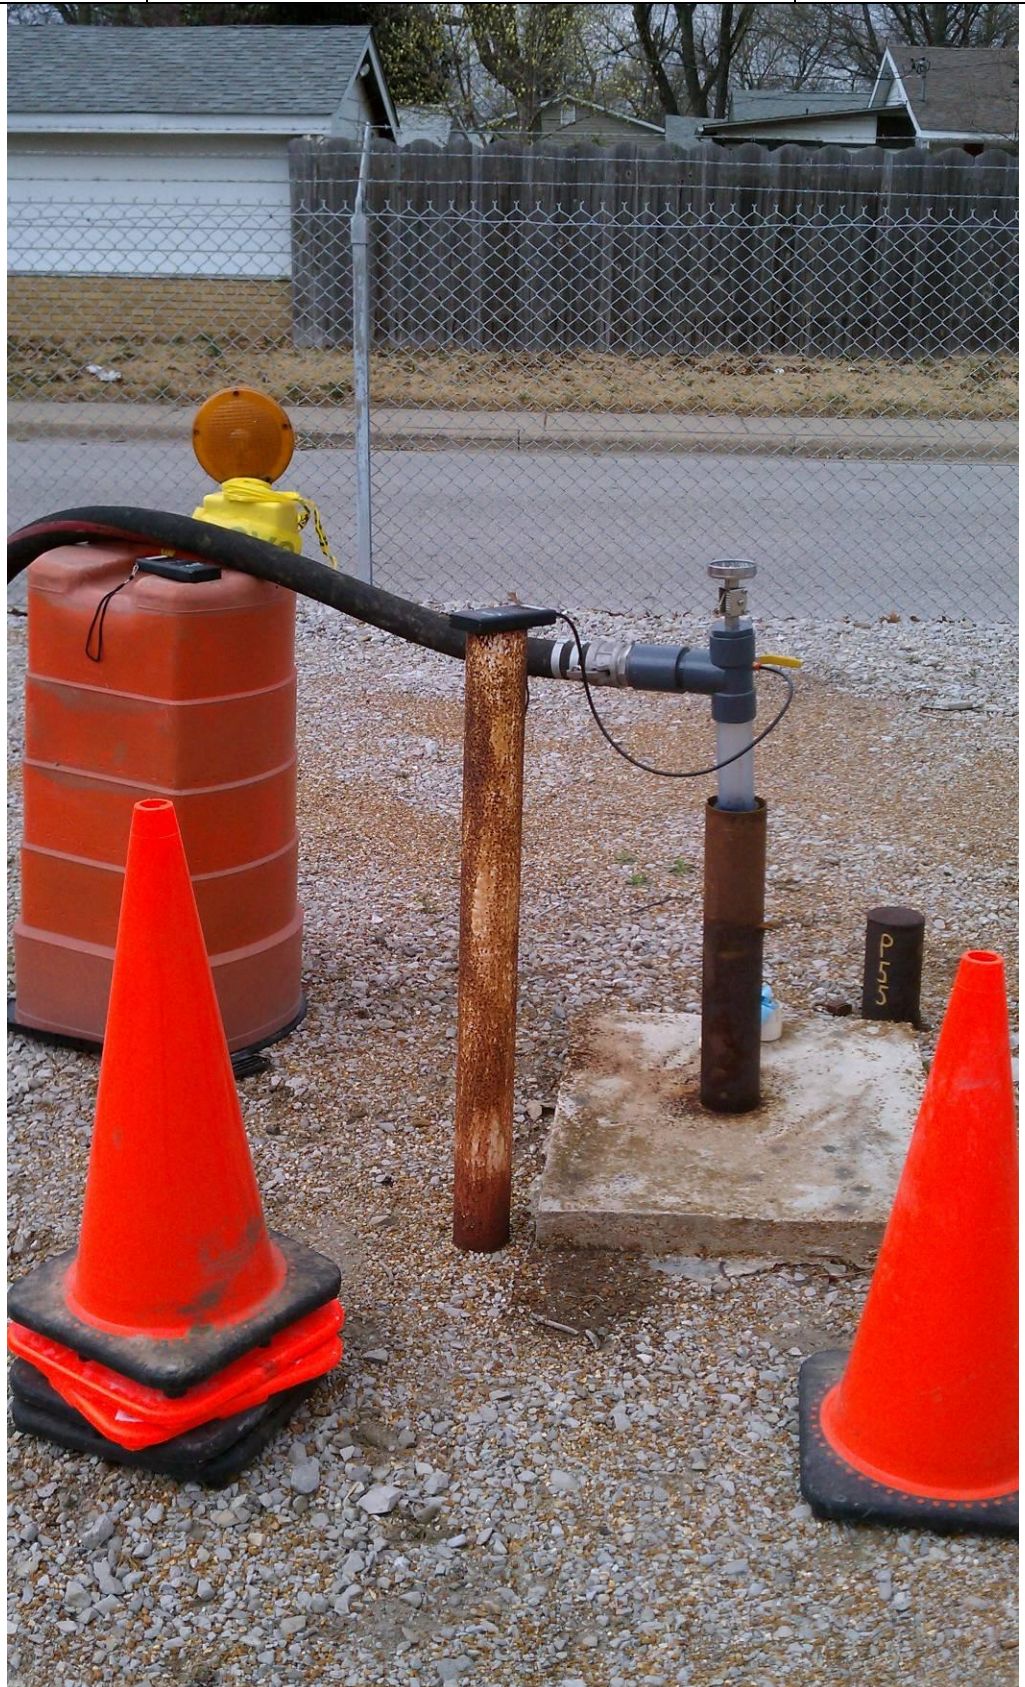
Extraction well apparatus – illustrating vacuum hose attachment and vacuum/pressure gauge attached to well head port.

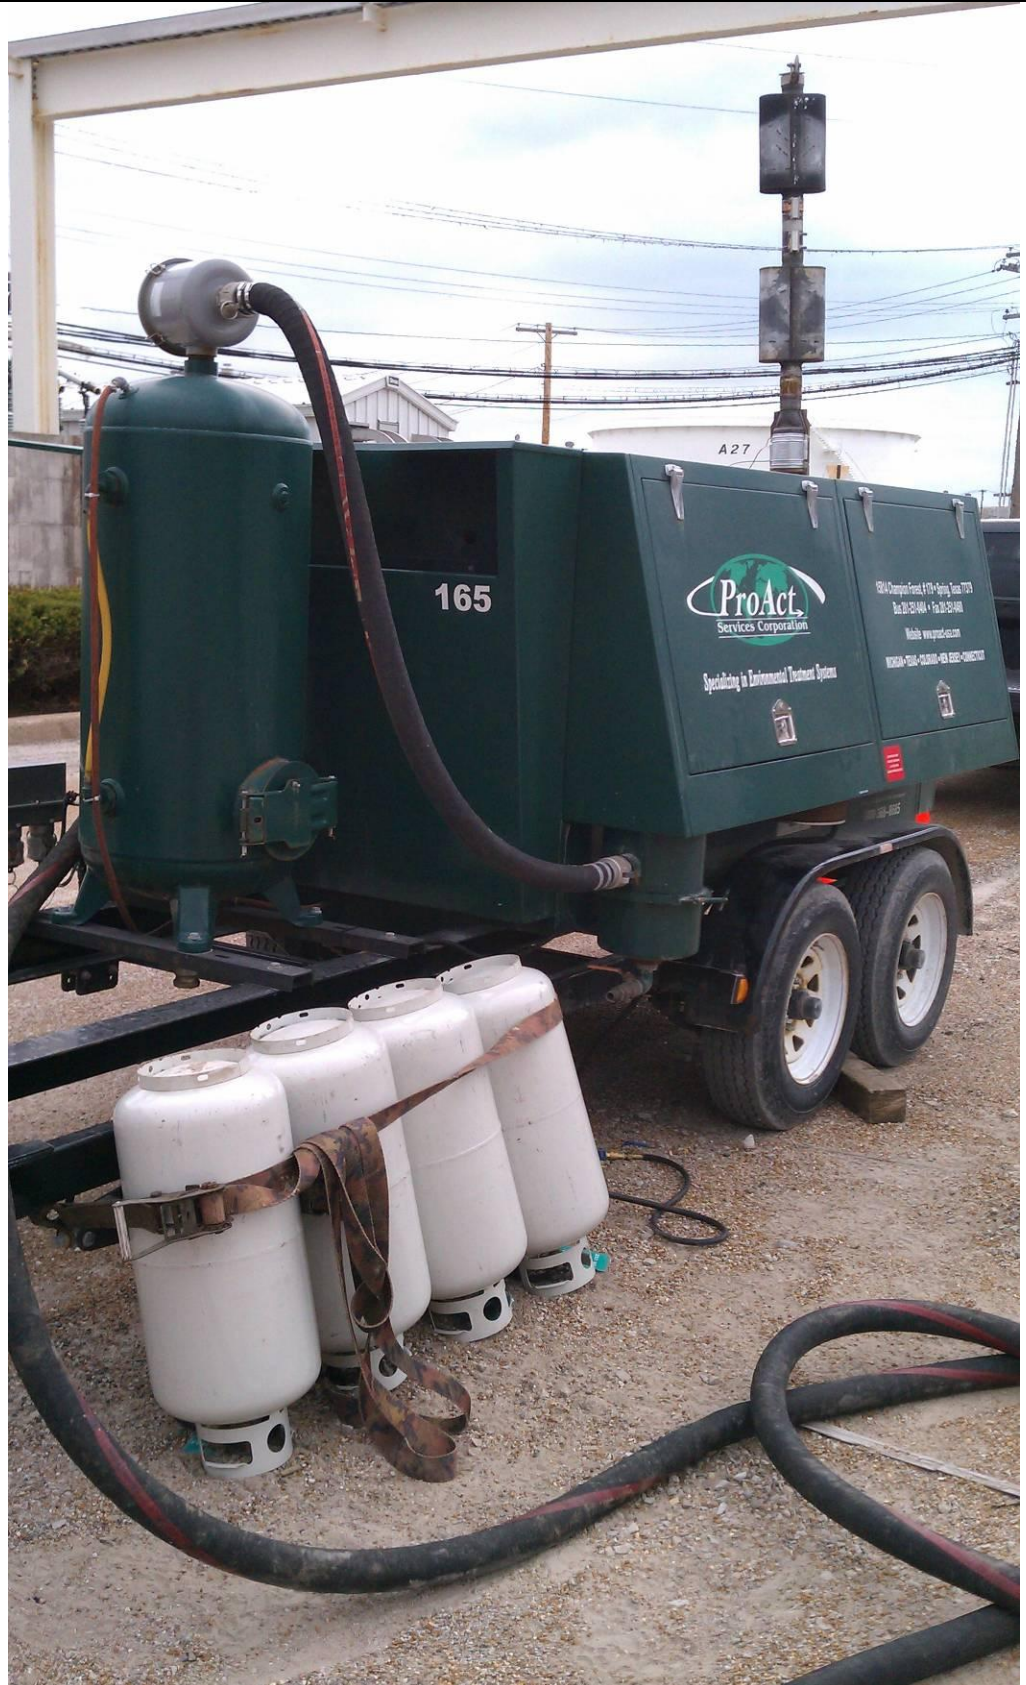
ICE Unit –
Illustrating portable
propane tanks for
supplemental fuel
and vacuum hose
connected to
extraction well.
